TOWN OF ESSEX CONNECTICUT
BUILDING COMMITTEE
CAPITAL PLANNING
REPORT
November 2014

Presented by
CME Associates, Inc.
32 Crabtree Lane
Woodstock, CT 06281

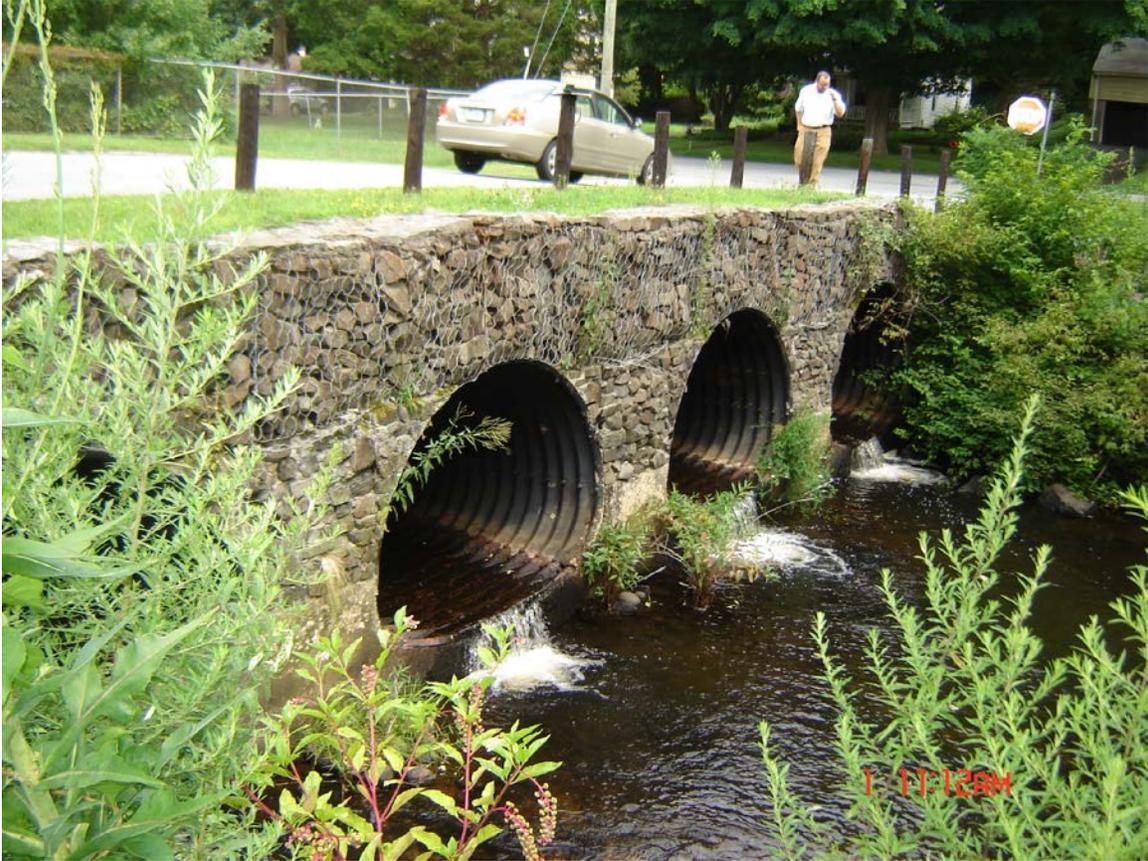
Bridge No. 04660, which carries Walnut Street over Falls River, was constructed in 1968 and consists of four asphalt-coated corrugated steel pipe arches. The most recent Connecticut Department of Transportation (ConnDOT) Routine and Special Inspection was performed on July 16, 2013. The report from this inspection indicates a Structure Evaluation Appraisal of 2, which is described as “Basically intolerable requiring high priority of replacement”. The bridge has been posted for a load limit of 10 Tons.

An application for funding under the ConnDOT Federal Local Bridge Program has been prepared based upon full replacement of the existing bridge with a new bridge meeting all current design standards.

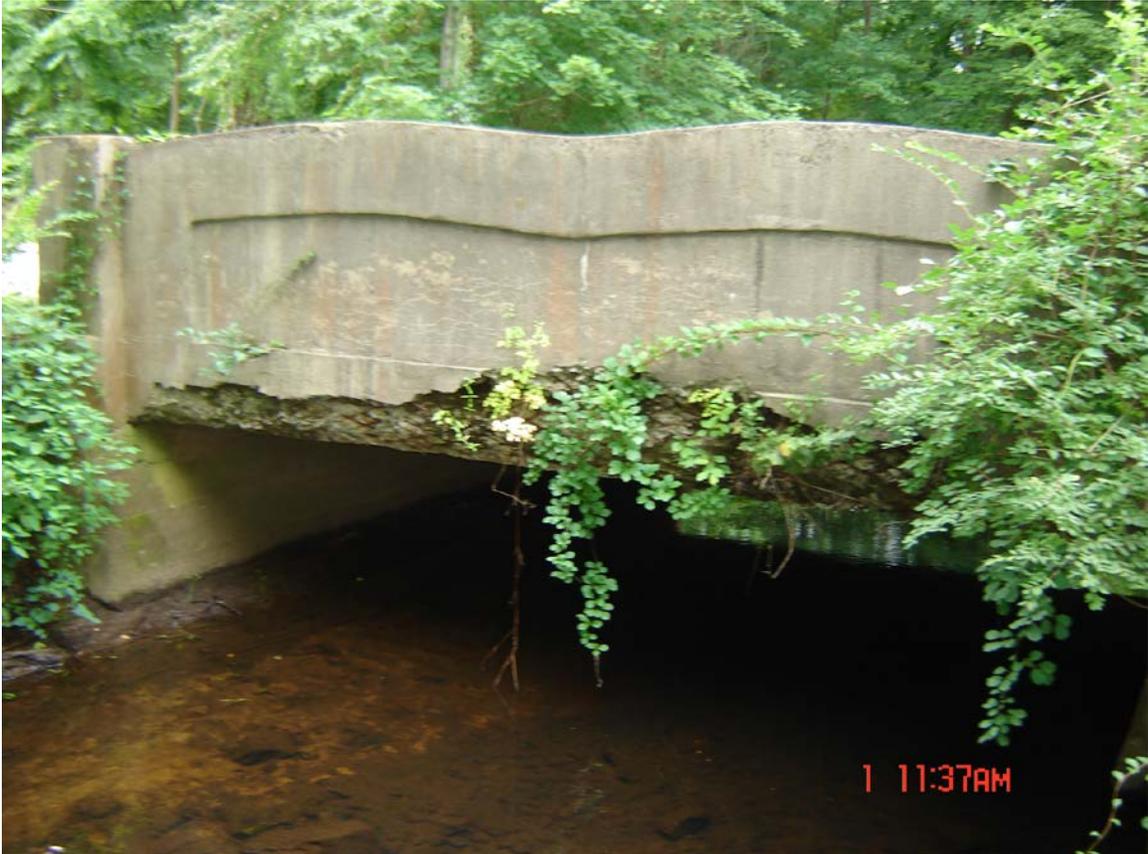
The Ivory Street bridges were built in 1940 and carry Ivory Street over separate branches of the Falls River. Both bridges are experiencing severe deterioration at the fascia of the deck slabs. This deterioration is also continuing up the integrally cast parapets. Additionally, the bridges are narrower than the approach roadway and have inadequate traffic protection.

The existing bridges will be removed and replaced with pre-cast three-sided box culverts. Wing walls and parapet wall will be replaced in the same location and footprint as existing components and will contain the gravel and pavement. Existing spans will be retained and no work in the existing channel will be needed. Boxes will be wide enough to span the existing river bottom. Railings will be installed atop the parapet walls and extended beyond the bridge length to protect pedestrians. Road and sidewalk restoration will take place post-replacement. No utility relocation is needed as part of the project.

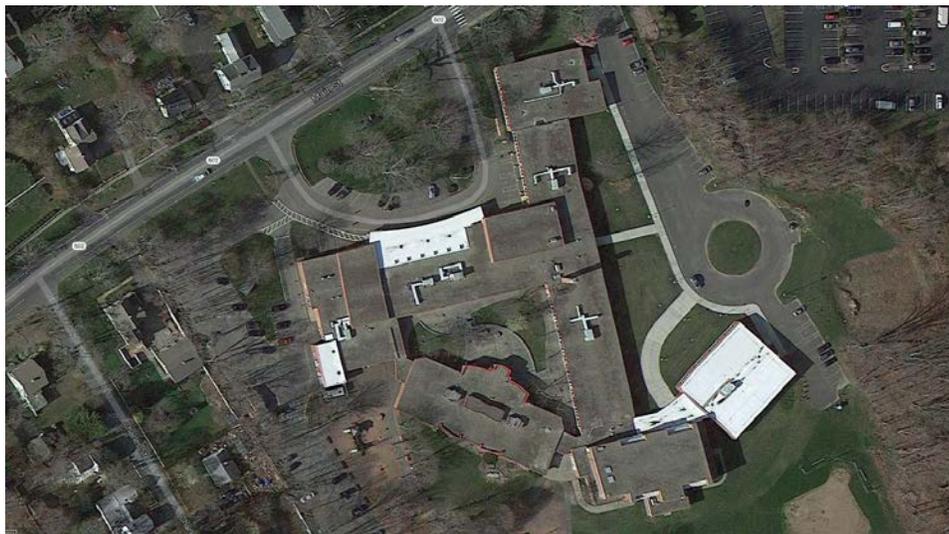
The Essex Elementary School roofing system consists of variety of roofing materials including ballasted EPDM and PVC membrane. The ballasted roofs were installed in 1992 and have exceeded their life expectancy but not without failures of the flashings and seams which have a 12 to 15 year life expectancy. The PVC membrane roofs were installed on the 2008 additions and are in good condition with a few isolated exceptions. A roof inspection by The Moriarty Corporation in September 2011 identified deficiencies in the existing roofing systems and recommended budgeting for roof replacement of the ballasted roofs within 3 years.

At this time, the ballasted roofs are in critical need of replacement. The PVC roofs should be repaired as necessary. New roof work should be coordinated with any expected modifications to rooftop HVAC equipment and energy efficiency measures such as day lighting and solar systems. The scope of work will include the following:

- Removal of the existing ballast, EPDM roof membrane and insulation;
- Installation of day lighting devices;
- Installation of new metal copings and flexible flashings at rooftop equipment;
- Installation of rigid insulation sloped ½” per foot to existing roof drains;
- Installation of new white PVC roof membrane;
- Repair of 2008 PVC roof flashings as necessary.

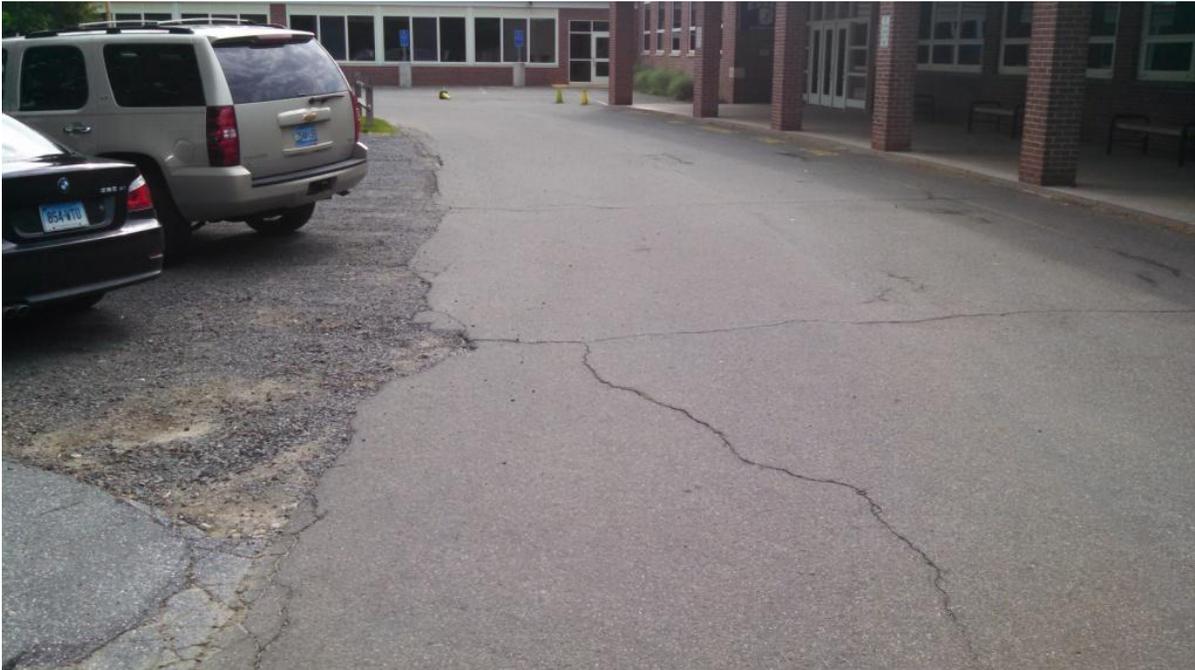
Existing parking areas have been expanded utilizing temporary measures including gravel. These areas are not compliant with Universal Accessibility standards and are prone to washout and further breakdown during the freeze / thaw cycle. Expanded on-site parking is warranted to address parking needs. Due to the deteriorated condition of the tennis courts and their adjacency to existing parking, this area has been identified as a potential expansion site.

Parking surfaces in the main entrance circle demonstrate the range of materials and conditions that are common in the areas where parking has been expanded.

Remove and replace the existing and proposed paved areas with a two coat asphalt surface on a renovated base layer. The existing surface will be removed and pulverized, replaced and compacted, and a new 2 inch base coat installed with a 1 1/2" top coat.

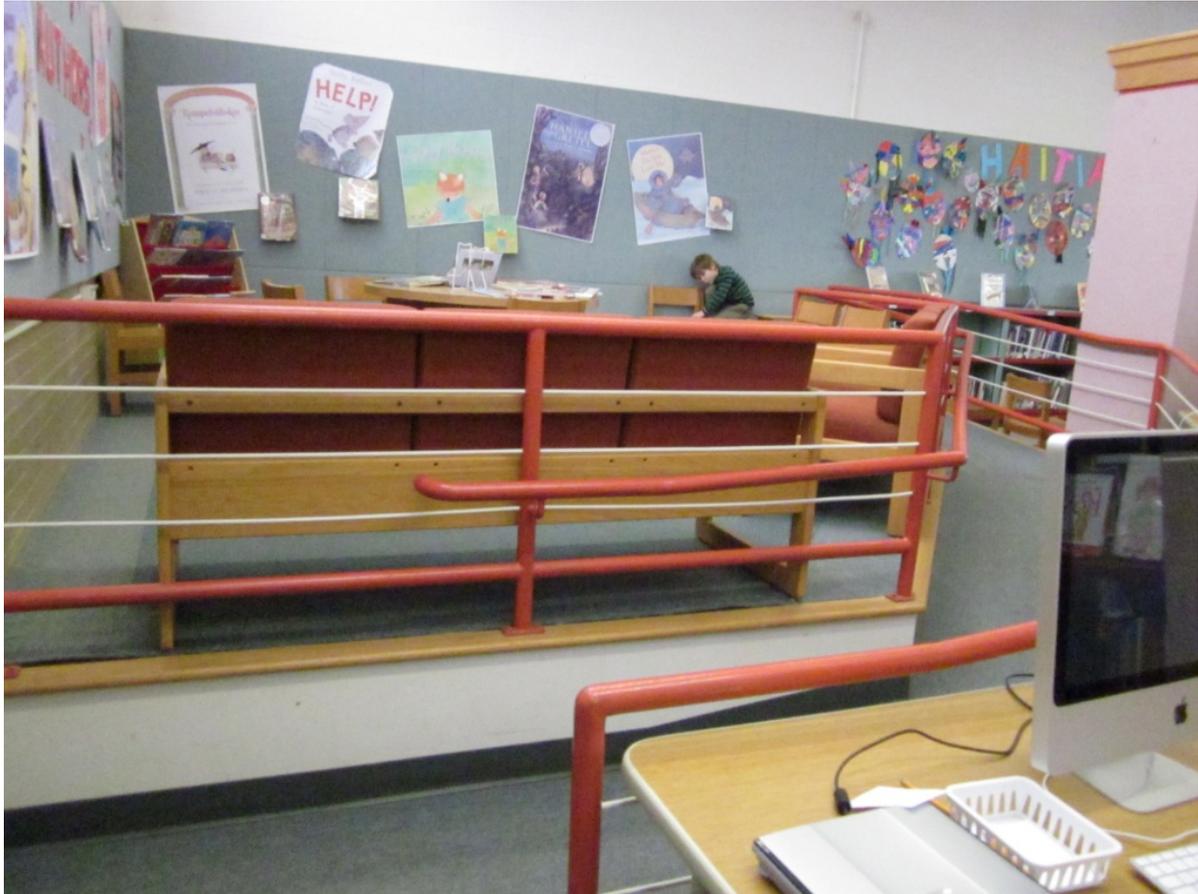
The Media Center floor system includes carpet installed over old mastic, containing hazardous materials, on a concrete slab. As the Elementary School prepares to renovate the Media Center, there is an opportunity to remove these hazardous materials.

During the course of demolition of the existing raised floor system and partitions, and in conjunction with the replacement of the existing carpeting, the mastic remaining from past floor finish systems should be removed by stripping and shot blasting the concrete slab.

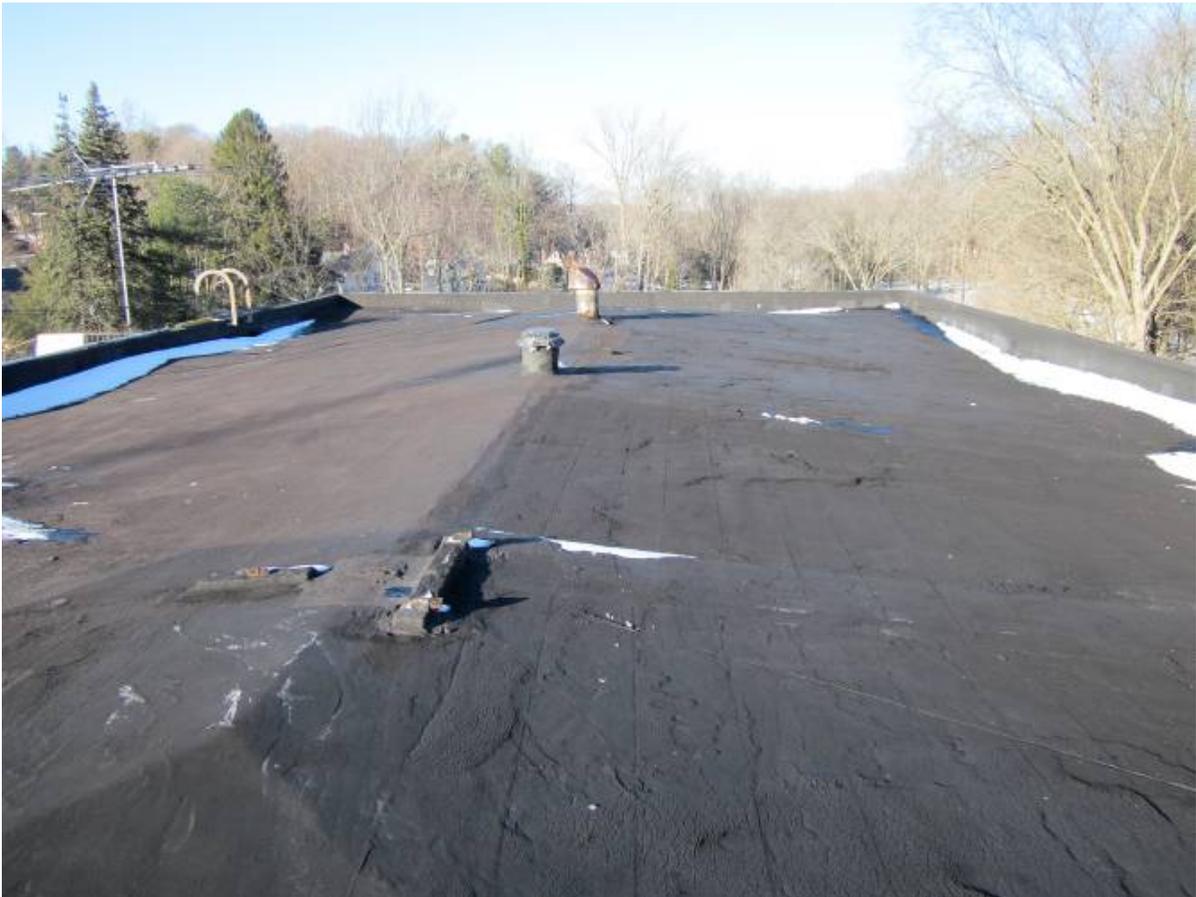
The Town Hall complex consists of four connected structures each with separate roof systems. The roof of the main 1922 building and of the Resident State Trooper building consists of a built up tar and felt roof membrane which has exceeded its expected useful life of 20 years. Additionally, there are active roof leaks which are affecting interior structure, finishes and indoor air quality.

Main roof looking north along the East wing.

The Main Building roof and the roof of the Resident Trooper Building should be completely removed down to the roof sheathing and replaced with a sloped, single ply TPO (thermoplastic polyolefin) roof system including rigid insulation and new aluminum coping. All work should be coordinated with anticipated upgrades to mechanical systems.

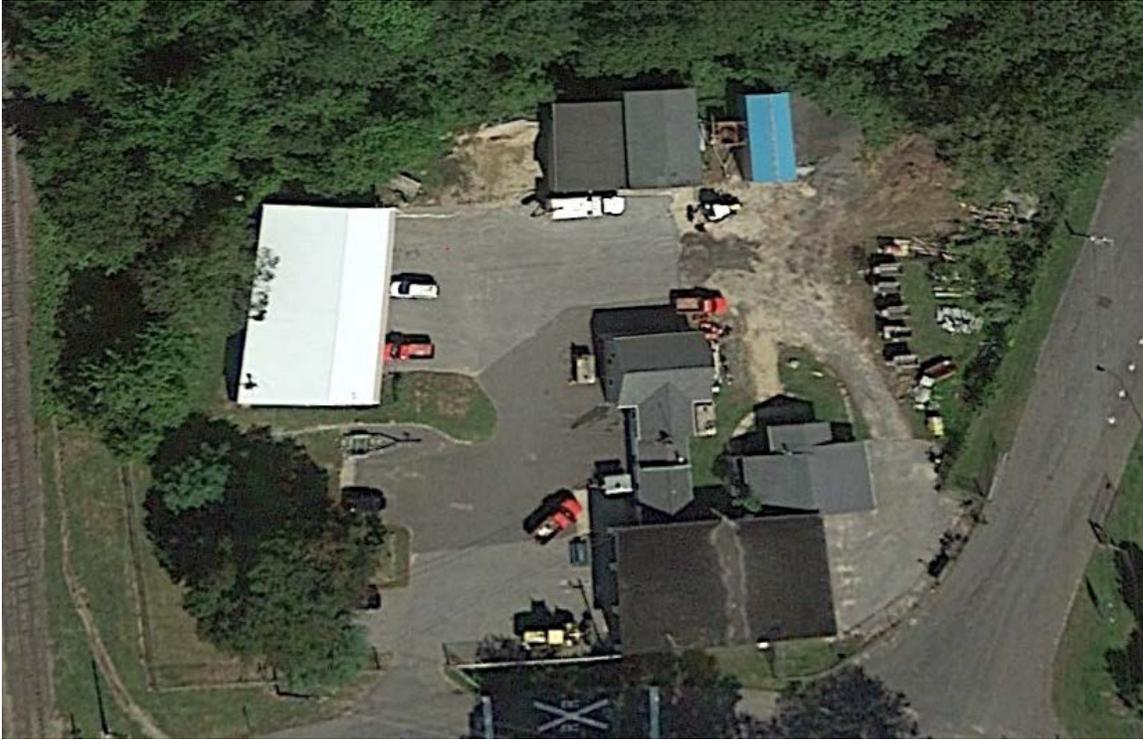
The 3,500 square foot single ply membrane roof of the garage building has outlived its useful life expectancy and is in need of replacement.

The circled roof over the repair and storage garages requires replacement.

Remove the existing membrane roof and install a new 60 mil insulated, white TPO single ply membrane roof and associated flashings and trim.

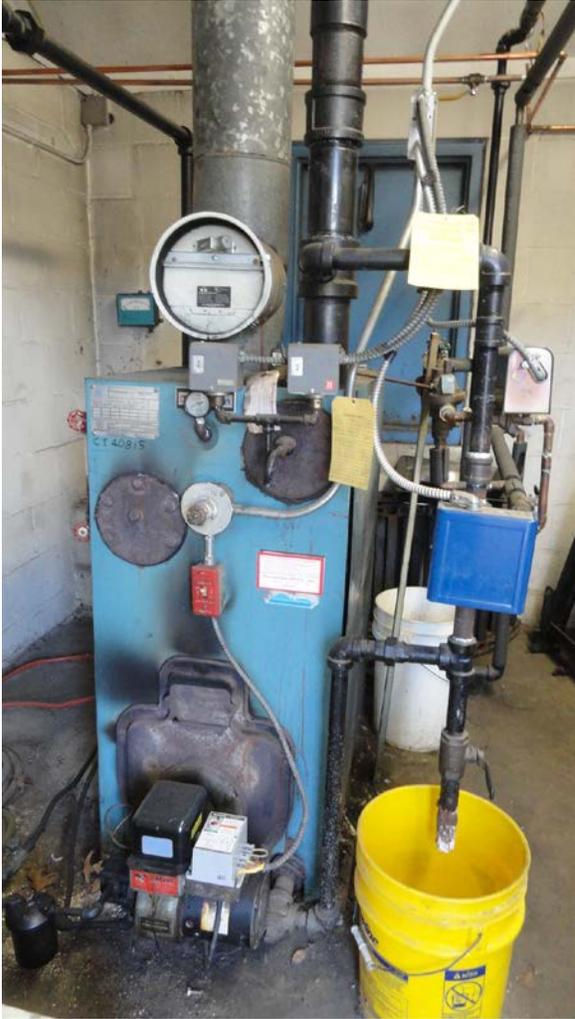
The existing boiler that serves the repair garage is inefficient equipment that has been renovated with a new burner but has overall reached the end of its service life.

Install a new high efficiency oil fired hot water boiler and associated breeching, piping to three zones, hydronic horizontal unit heaters and associated thermostats and controls to will provide energy efficiencies and cost savings.

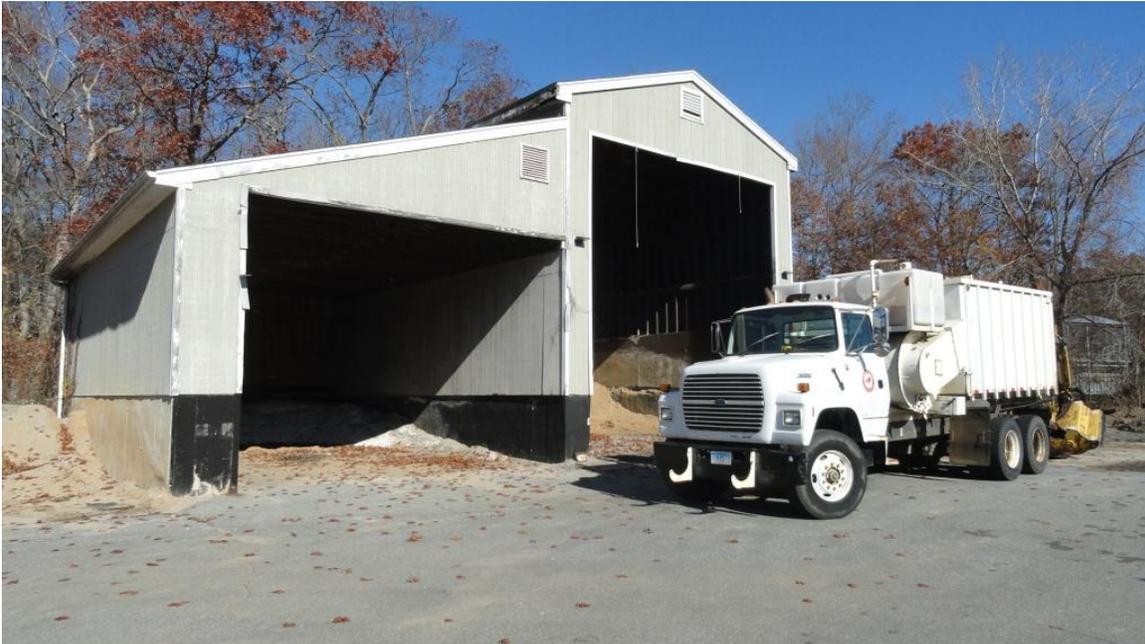
Covered storage for both materials and equipment is a necessity at the Public Works Department facility on Dump Road. Large equipment such as the Over the Rail Mower and the VACALL catch basin cleaner are currently stored inadequately. Sanders and plows are currently stored out in the open

The existing salt / sand shed could be expanded to include a two bay storage garage for large equipment such as the VACALL shown. Open shed roof structures could house other equipment that is currently stored in the open.

Storage for equipment such as the Over the Rail Mower and the VACALL catch basin cleaner is required to protect the town's investment in this machinery. Sanders and plows which are currently stored out in the open should be protected from the elements in order to increase their useful life. A two bay garage addition to the right side of the salt shed will accommodate the equipment and minimize the impact of additional buildings on the small site. Open shed roof additions off both sides of the modified salt shed / garage building will provide needed storage for the sanders and plows. The existing site built open storage shed should be relocated and installed on full frost walls to insure its stability into the future.

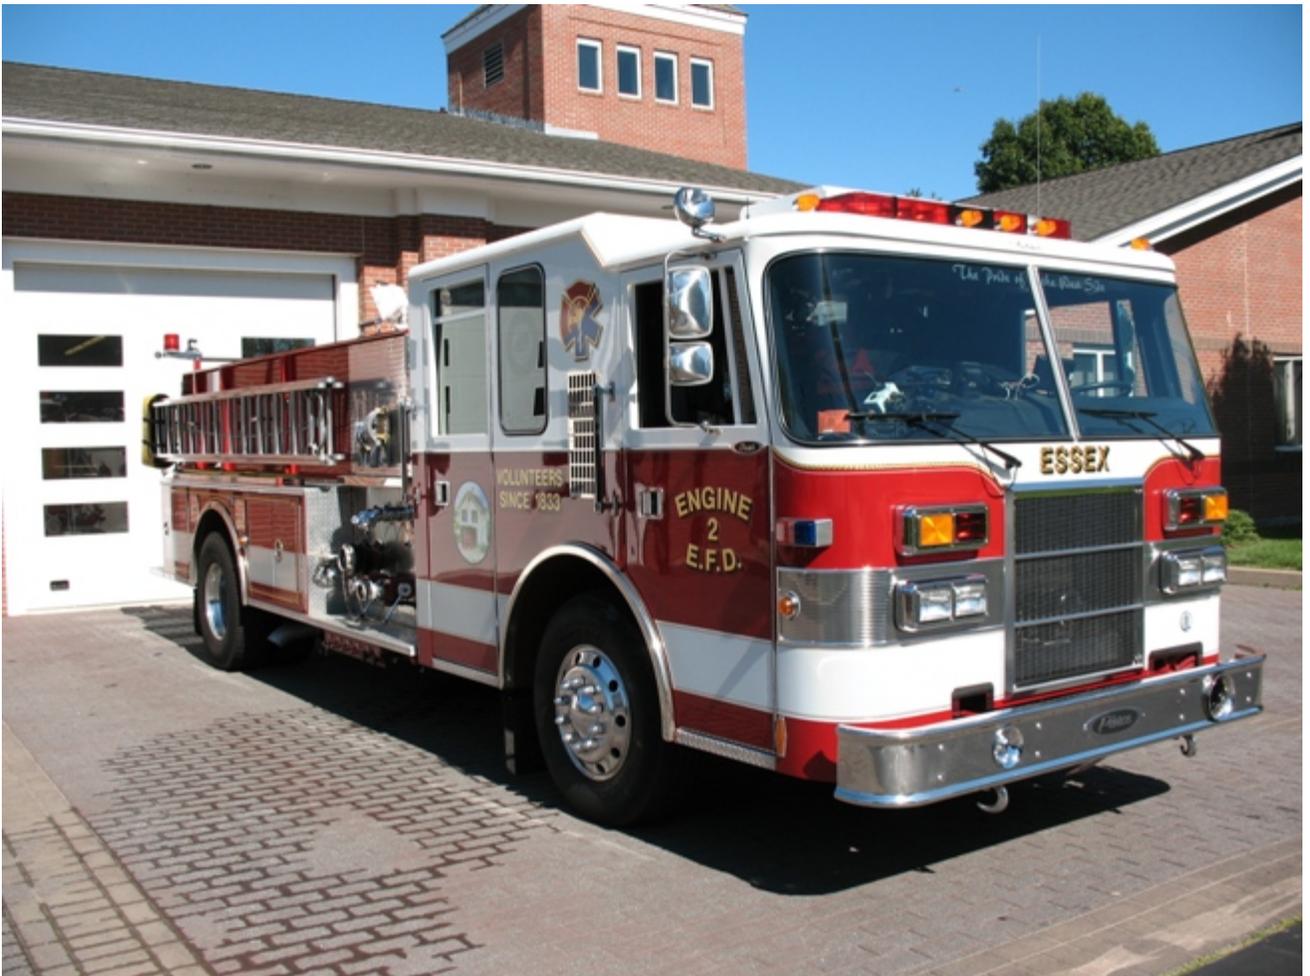
The Essex Fire Department has developed a 10 year plan that addresses the ongoing needs of the department for equipment and apparatus. The immediate need is for the replacement of the 1994 Pierce Dash pumper engine which was purchased new and is now thirty years old.

Engine 2: 1994 Pierce Dash pumper.

As per the National Fire Protection Association recommendations, fire apparatus over 20 years old should only be used as back up equipment. The pumper truck should be replaced with a suitably designed truck that can be accommodated within the space limitations of the Ivoryton Fire Station.
