TOWN OF ESSEX CONNECTICUT
BUILDING COMMITTEE
CAPITAL PLANNING
REPORT
AUGUST 2014

ESSEX BUILDING COMMITTEE

Presented by
CME Associates, Inc.
32 Crabtree Lane
Woodstock, CT 06281

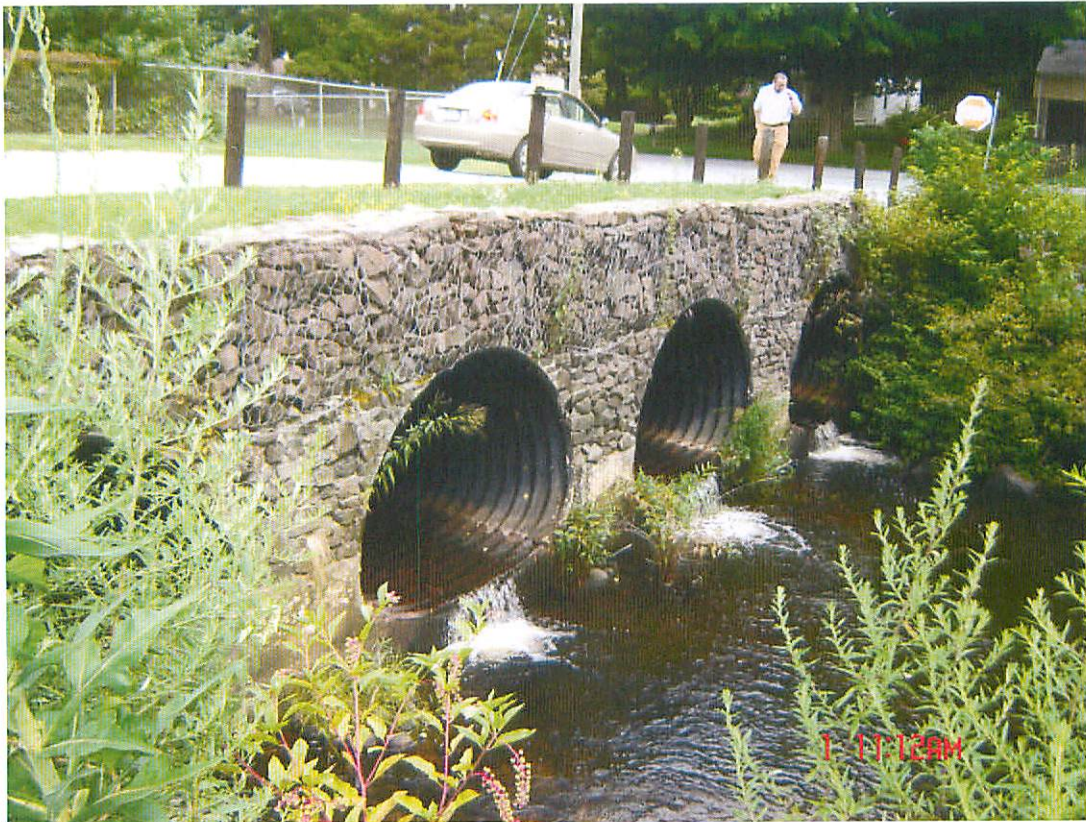
Bridge No. 04660, which carries Walnut Street over Falls River, was constructed in 1968 and consists of four asphalt-coated corrugated steel pipe arches. The most recent Connecticut Department of Transportation (ConnDOT) Routine and Special Inspection was performed on July 16, 2013. The report from this inspection indicates a Structure Evaluation Appraisal of 2, which is described as “Basically intolerable requiring high priority of replacement”. The bridge has been posted for a load limit of 10 Tons.

An application for funding under the ConnDOT Federal Local Bridge Program has been prepared based upon full replacement of the existing bridge with a new bridge meeting all current design standards.

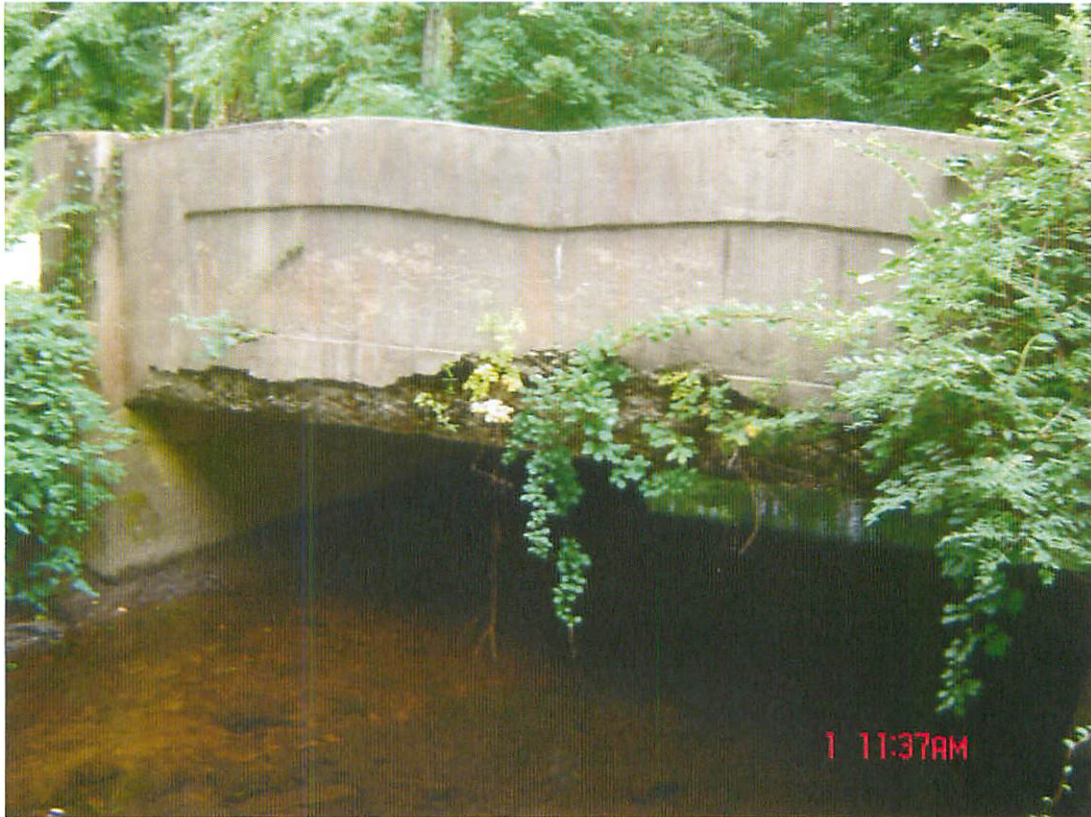
The Ivory Street bridges were built in 1940 and carry Ivory Street over separate branches of the Falls River. Both bridges are experiencing severe deterioration at the fascia of the deck slabs. This deterioration is also continuing up the integrally cast parapets. Additionally, the bridges are narrower than the approach roadway and have inadequate traffic protection.

The existing bridges will be removed and replaced with pre-cast three-sided box culverts. Wing walls and parapet wall will be replaced in the same location and footprint as existing components and will contain the gravel and pavement. Existing spans will be retained and no work in the existing channel will be needed. Boxes will be wide enough to span the existing river bottom. Railings will be installed atop the parapet walls and extended beyond the bridge length to protect pedestrians. Road and sidewalk restoration will take place post-replacement. No utility relocation is needed as part of the project.

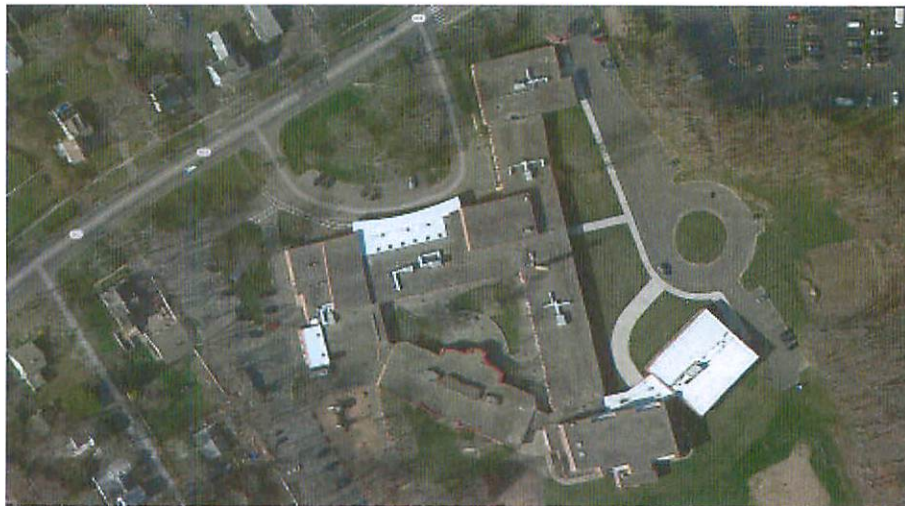
The Essex Elementary School roofing system consists of variety of roofing materials including ballasted EPDM and PVC membrane. The ballasted roofs were installed in 1992 and have exceeded their life expectancy but not without failures of the flashings and seams which have a 12 to 15 year life expectancy. The PVC membrane roofs were installed on the 2008 additions and are in good condition with a few isolated exceptions. A roof inspection by The Moriarty Corporation in September 2011 identified deficiencies in the existing roofing systems and recommended budgeting for roof replacement of the ballasted roofs within 3 years.

At this time, the ballasted roofs are in critical need of replacement. The PVC roofs should be repaired as necessary. New roof work should be coordinated with any expected modifications to rooftop HVAC equipment and energy efficiency measures such as day lighting and solar systems. The scope of work will include the following:

- Removal of the existing ballast, EPDM roof membrane and insulation;
- Installation of day lighting devices;
- Installation of new metal copings and flexible flashings at rooftop equipment;
- Installation of rigid insulation sloped ½" per foot to existing roof drains;
- Installation of new white PVC roof membrane;
- Repair of 2008 PVC roof flashings as necessary.

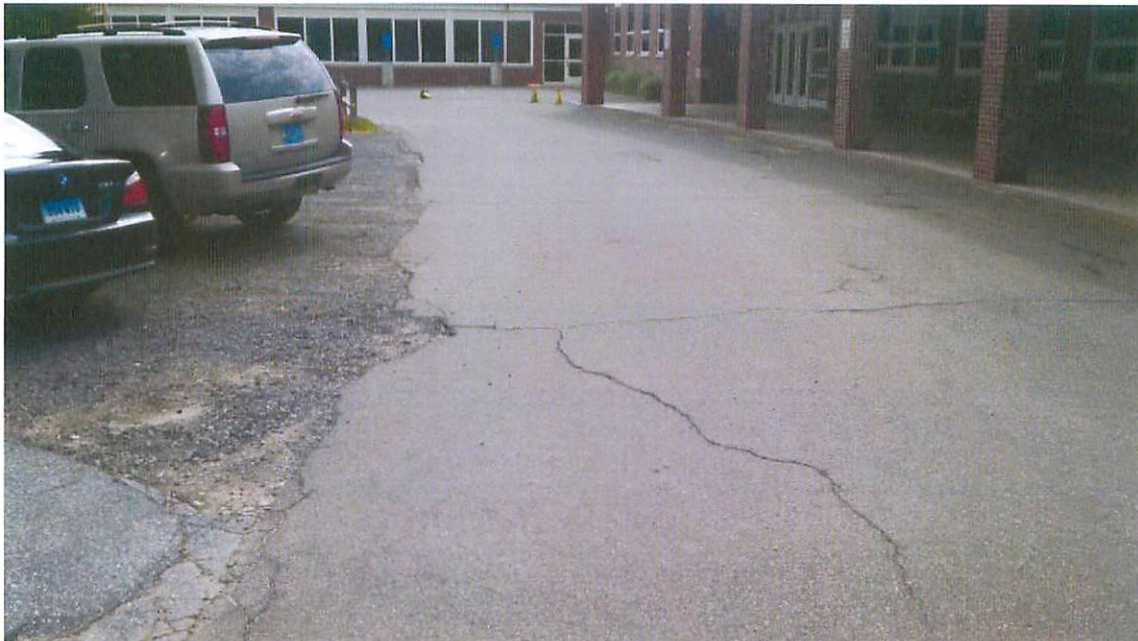
Existing parking areas have been expanded utilizing temporary measures including gravel. These areas are not compliant with Universal Accessibility standards and are prone to washout and further breakdown during the freeze / thaw cycle. Expanded on-site parking is warranted to address parking needs. Due to the deteriorated condition of the tennis courts and their adjacency to existing parking, this area has been identified as a potential expansion site.

Parking surfaces in the main entrance circle demonstrate the range of materials and conditions that are common in the areas where parking has been expanded.

Remove and replace the existing and proposed paved areas with a two coat asphalt surface on a renovated base layer. The existing surface will be removed and pulverized, replaced and compacted, and a new 2 inch base coat installed with a 1 1/2" top coat.

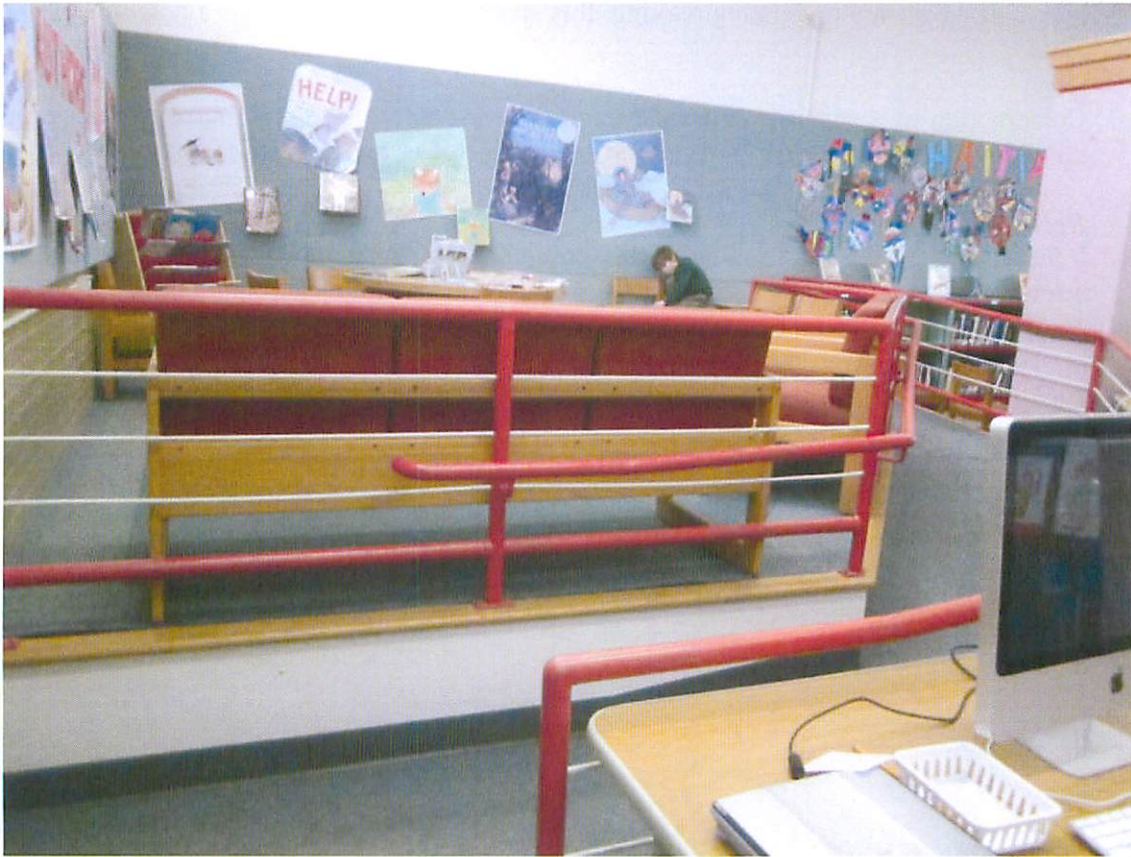
The Media Center floor system includes carpet installed over old mastic, containing hazardous materials, on a concrete slab. As the Elementary School prepares to renovate the Media Center, there is an opportunity to remove these hazardous materials.

During the course of demolition of the existing raised floor system and partitions, and in conjunction with the replacement of the existing carpeting, the mastic remaining from past floor finish systems should be removed by stripping and shot blasting the concrete slab.

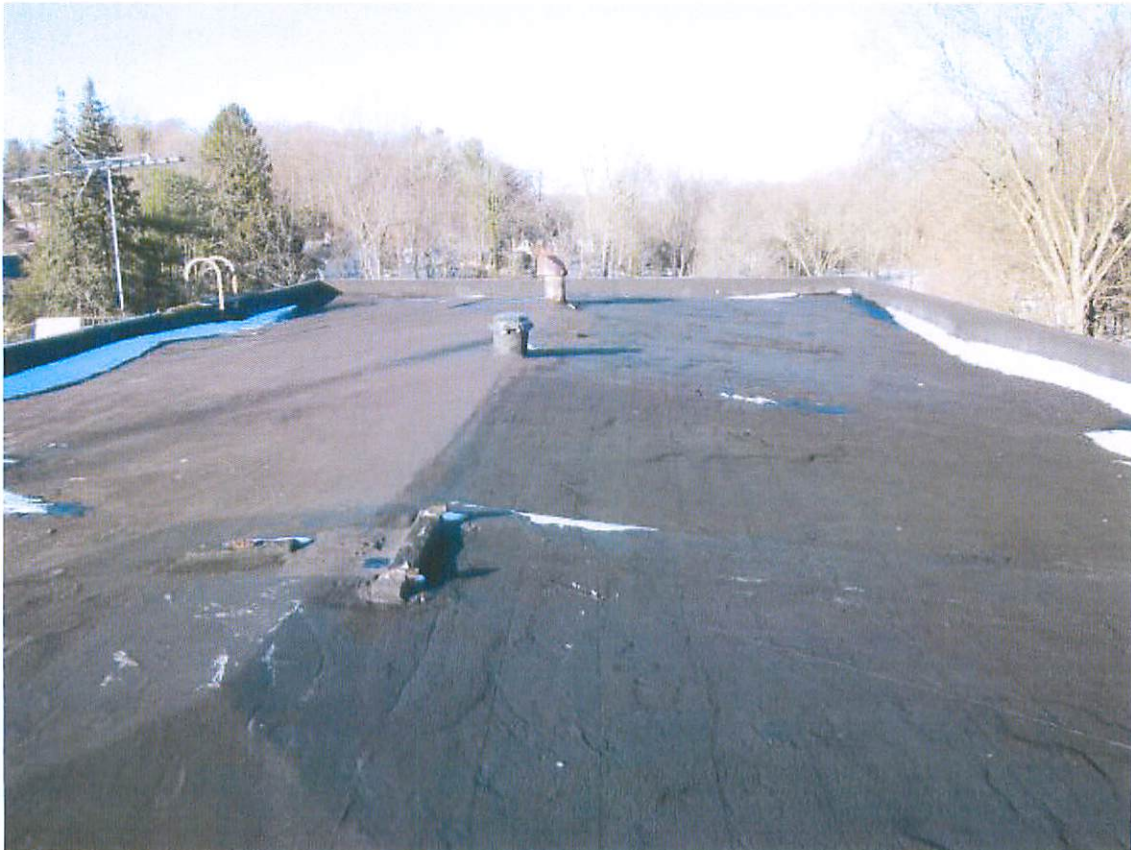
The Town Hall complex consists of four connected structures each with separate roof systems. The roof of the main 1922 building and of the Resident State Trooper building consists of a built up tar and felt roof membrane which has exceeded its expected useful life of 20 years. Additionally, there are active roof leaks which are affecting interior structure, finishes and indoor air quality.

Main roof looking north along the East wing.

The Main Building roof and the roof of the Resident Trooper Building should be completely removed down to the roof sheathing and replaced with a sloped, single ply TPO (thermoplastic polyolefin) roof system including rigid insulation and new aluminum coping. All work should be coordinated with anticipated upgrades to mechanical systems.

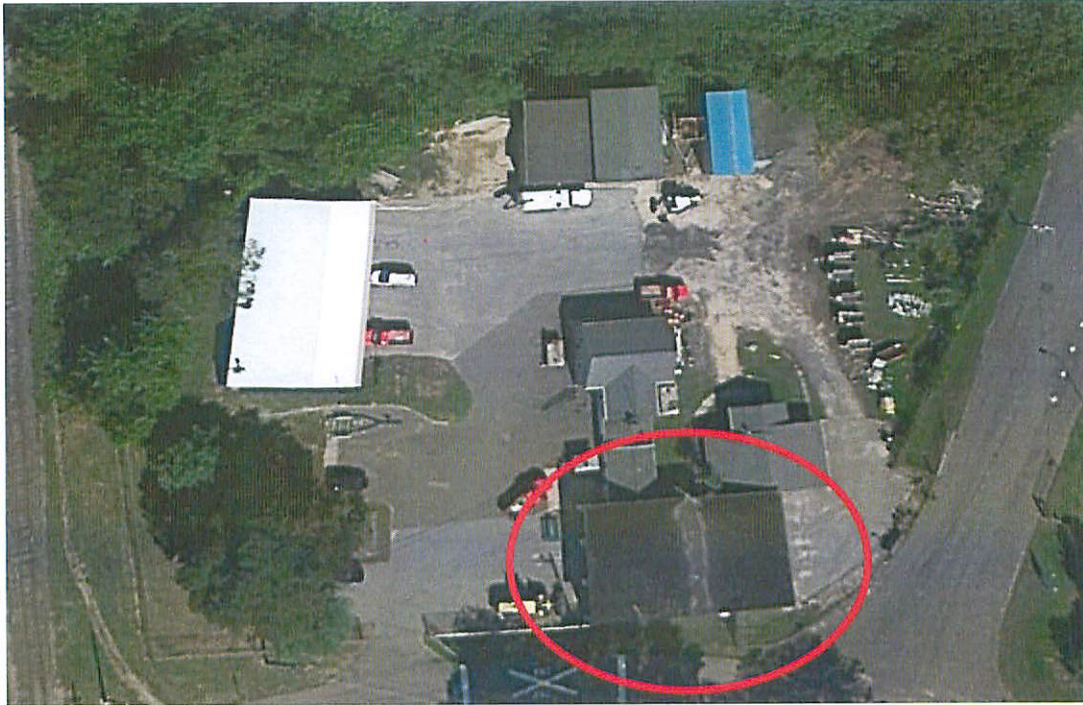
The 3,500 square foot single ply membrane roof of the garage building has outlived its useful life expectancy and is in need of replacement.

The circled roof over the repair and storage garages requires replacement.

Remove the existing membrane roof and install a new 60 mil insulated, white TPO single ply membrane roof and associated flashings and trim.

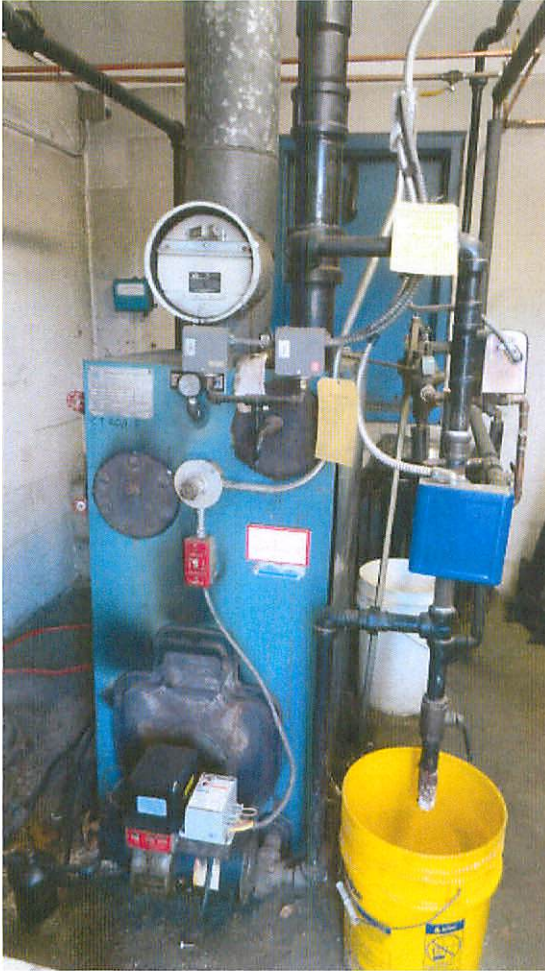
The existing boiler that serves the repair garage is inefficient equipment that has been renovated with a new burner but has overall reached the end of its service life.

Install a new high efficiency oil fired hot water boiler and associated breeching, piping to three zones, hydronic horizontal unit heaters and associated thermostats and controls to will provide energy efficiencies and cost savings.

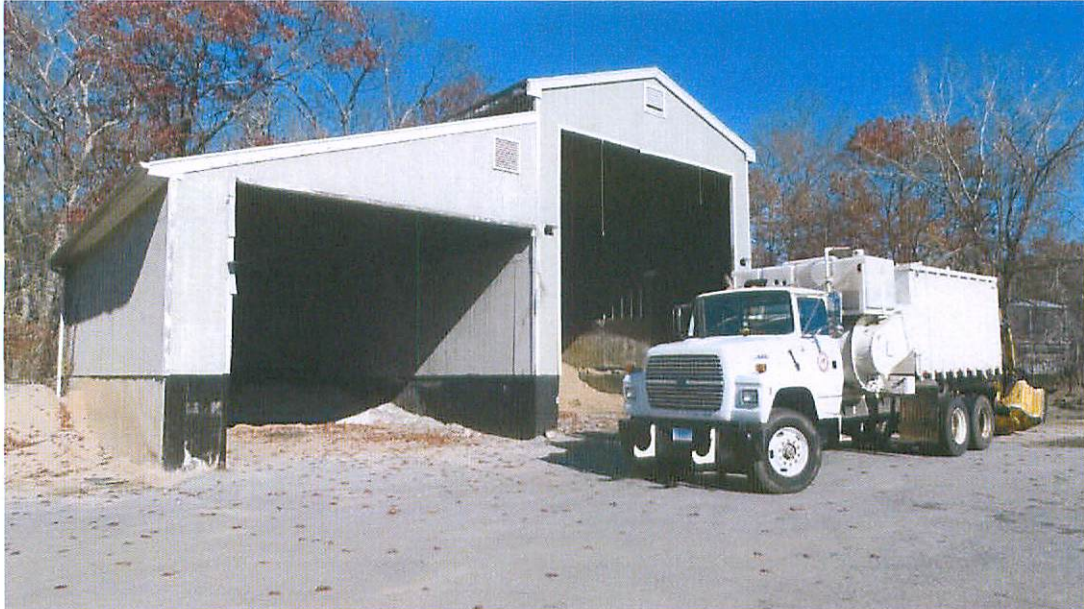
Covered storage for both materials and equipment is a necessity at the Public Works Department facility on Dump Road. Large equipment such as the Over the Rail Mower and the VACALL catch basin cleaner are currently stored inadequately. Sanders and plows are currently stored out in the open

The existing salt / sand shed could be expanded to include a two bay storage garage for large equipment such as the VACALL shown. Open shed roof structures could house other equipment that is currently stored in the open.

Storage for equipment such as the Over the Rail Mower and the VACALL catch basin cleaner is required to protect the town's investment in this machinery. Sanders and plows which are currently stored out in the open should be protected from the elements in order to increase their useful life. A two bay garage addition to the right side of the salt shed will accommodate the equipment and minimize the impact of additional buildings on the small site. Open shed roof additions off both sides of the modified salt shed / garage building will provide needed storage for the sanders and plows. The existing site built open storage shed should be relocated and installed on full frost walls to insure its stability into the future.
