A COMPREHENSIVE STUDY
OF ESSEX HARBOR AND
THATCHBED ISLAND
ESSEX, CONNECTICUT

FOR THE PURPOSE OF AN UPDATED HARBOR
MANAGEMENT PLAN.

For: Essex Harbor Commission

By: Docko, Inc. and associates

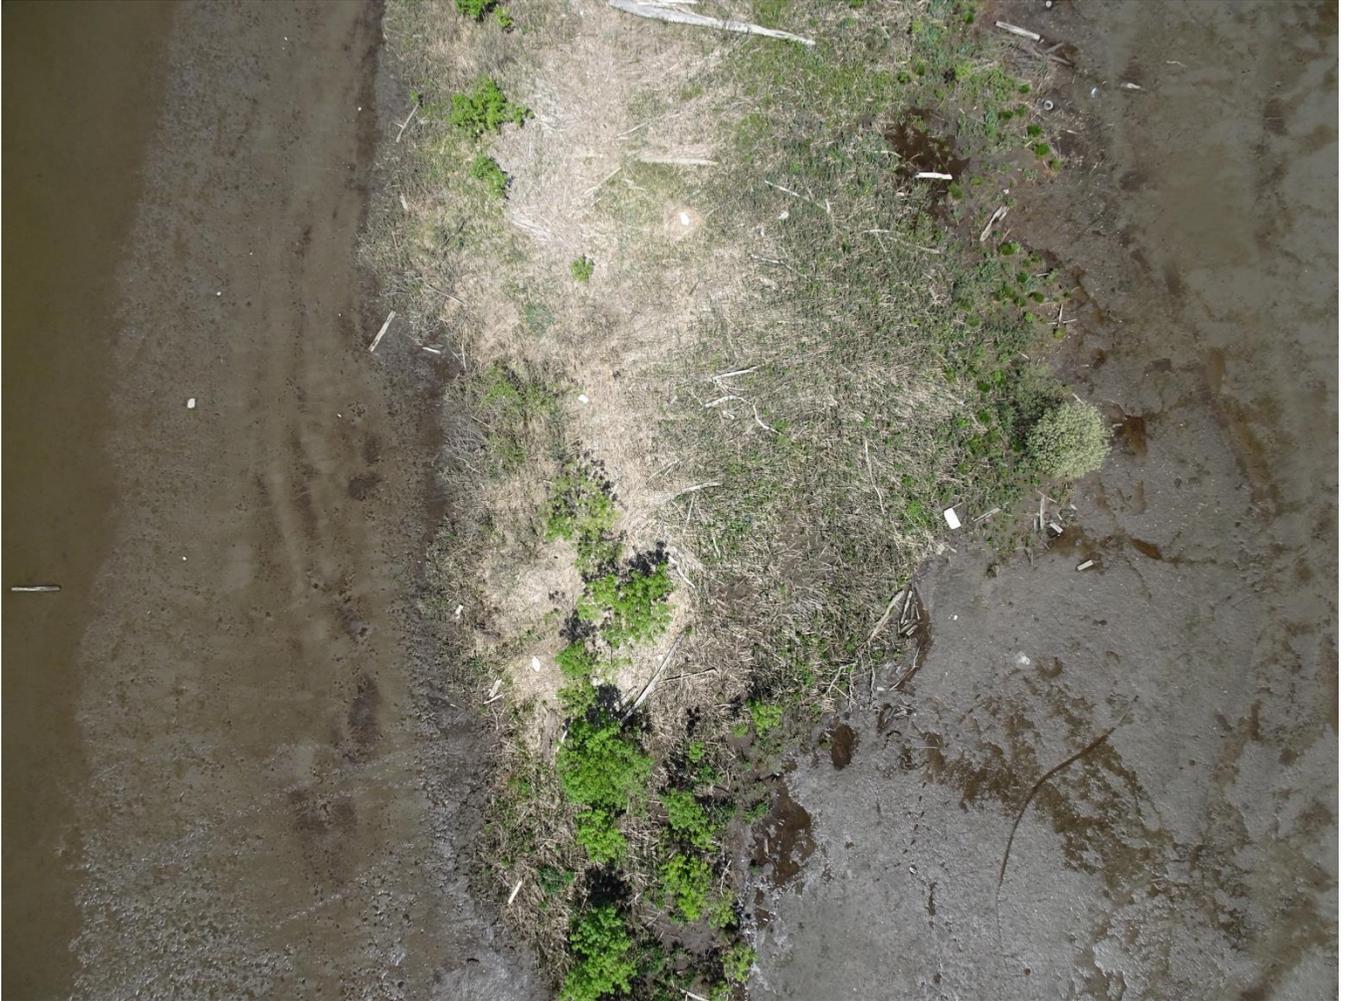
Figure 1: Debris line over Thatchbed Island

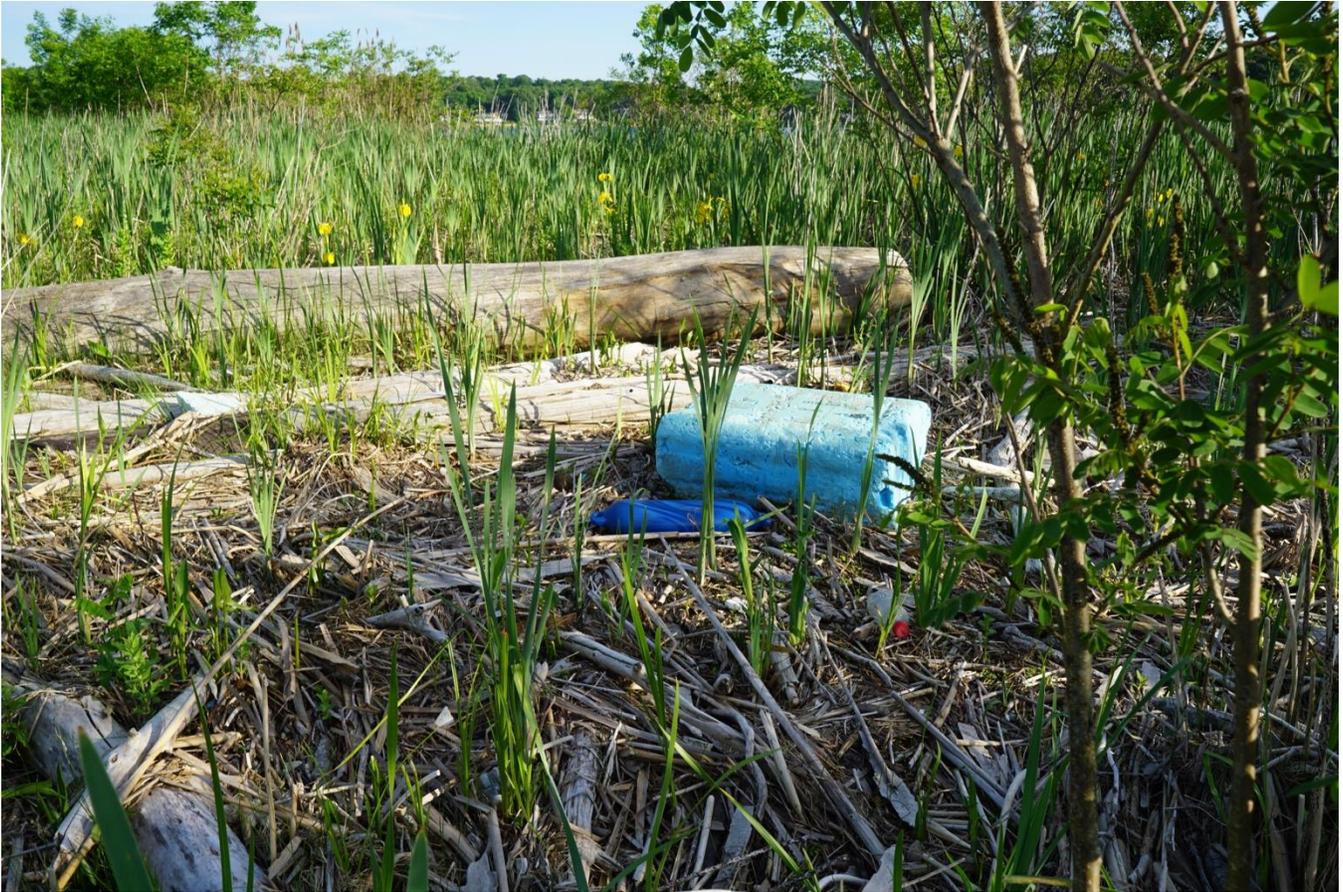
Figure 2: Debris line

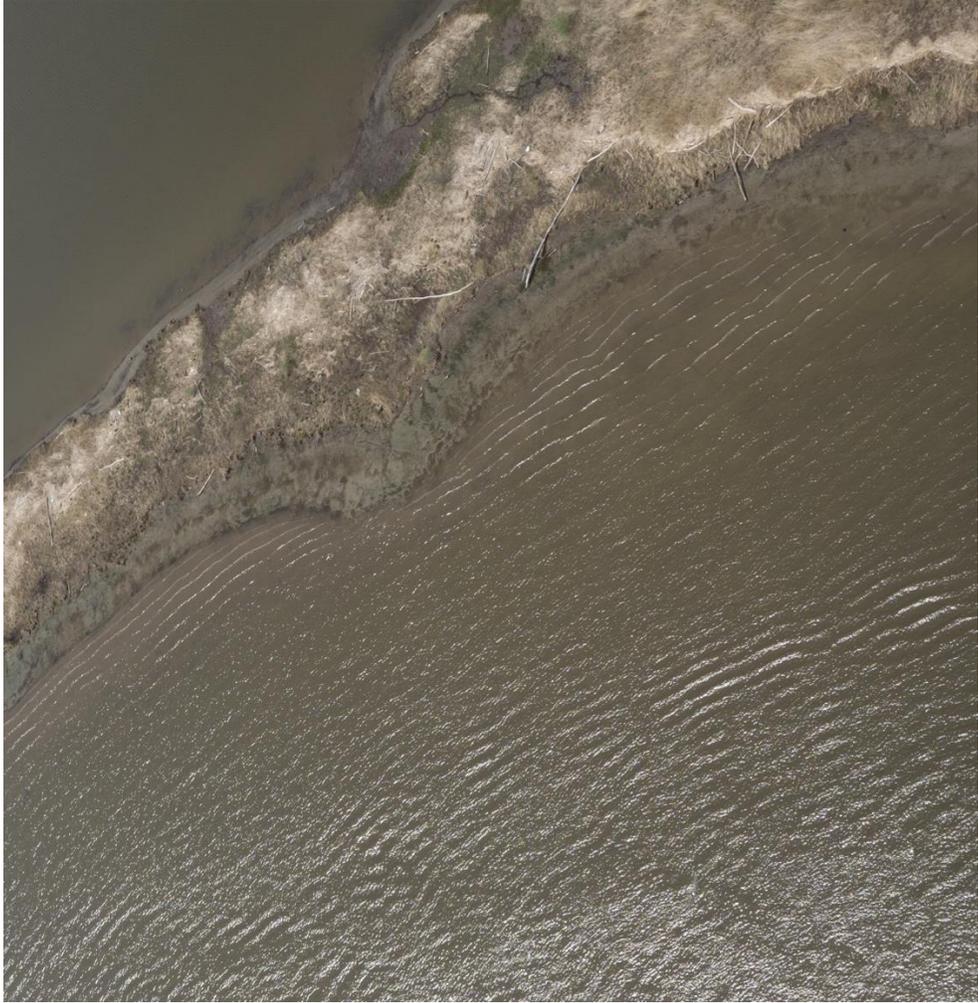
Figure 3: Boat wake hitting the easterly side of Thatchbed Island

These small wake induced waves, generated by any moving boat traffic have the ability to continually wear and tear at the silty, very fine sandy sediments which comprise the shoreline of Thatchbed Island yielding this easterly face of the island, subject to continuous erosion.

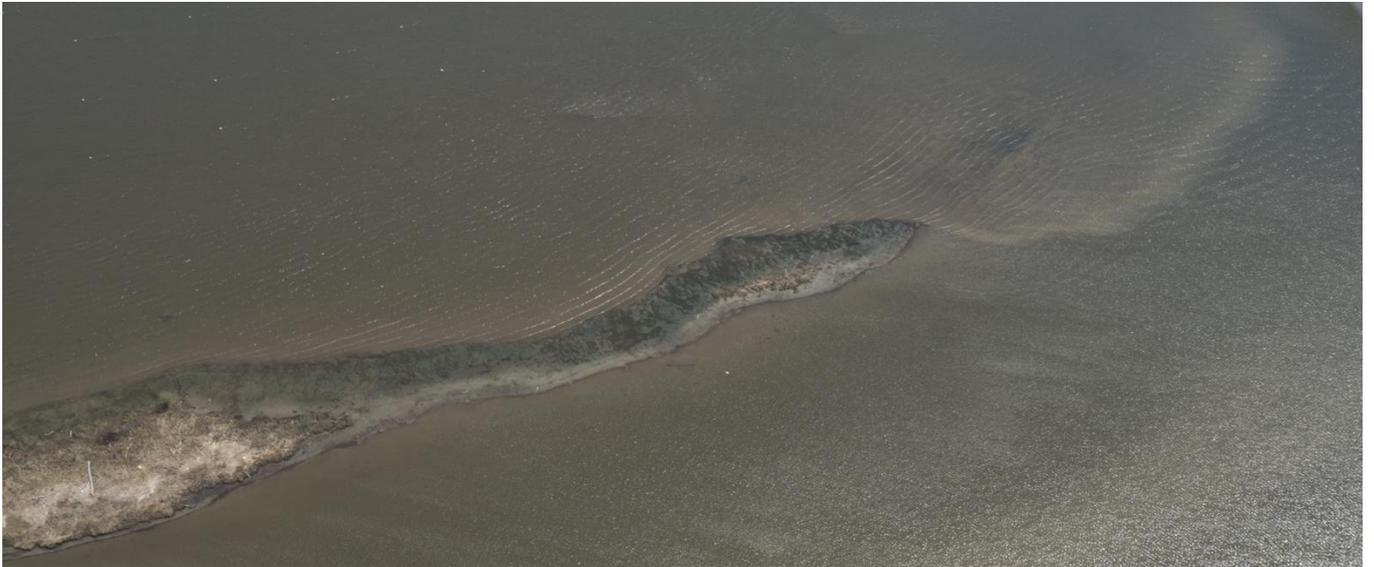
Figure 4: Aerial view of boat wakes hitting easterly side of Thatchbed Island

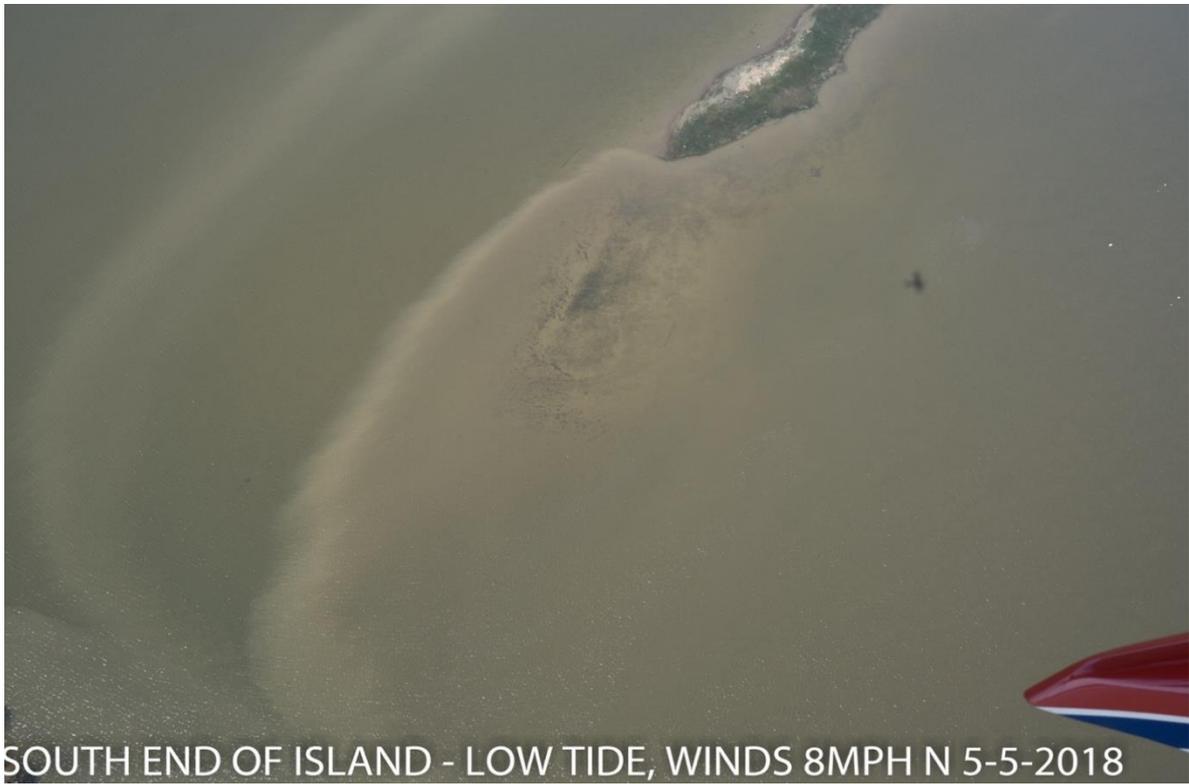
Figure 5: Wind generated wakes

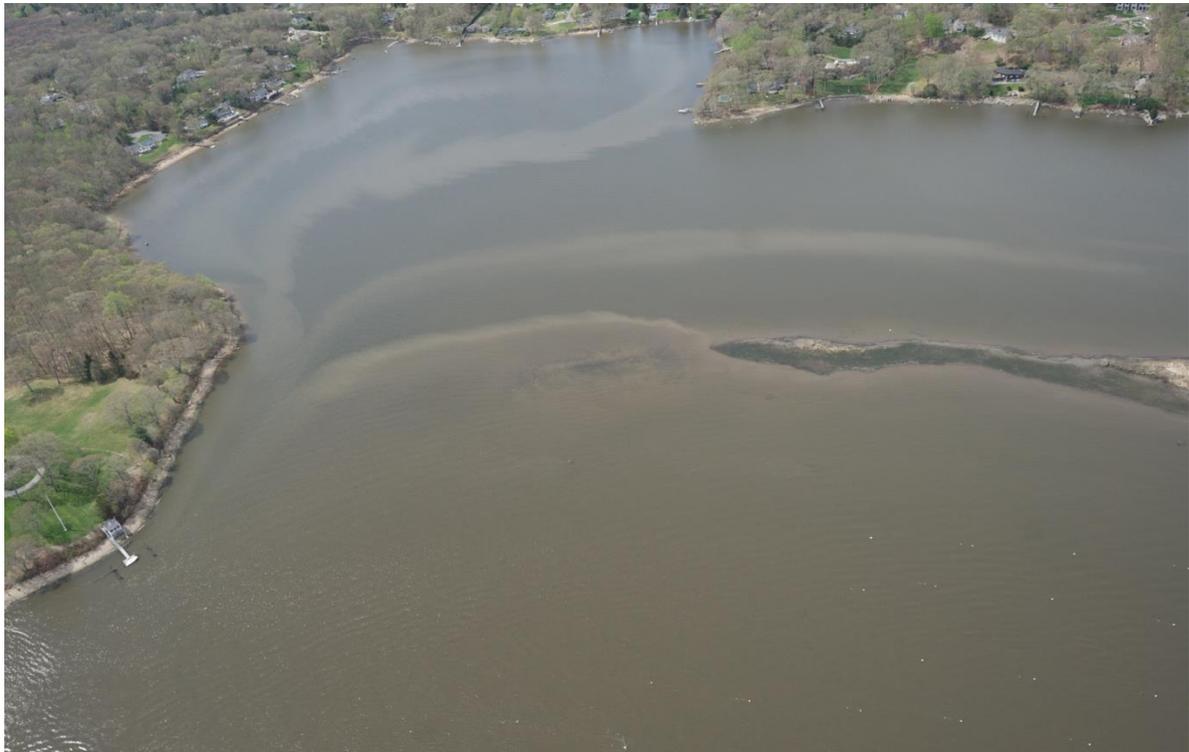
Figure 6: Wind generated wakes

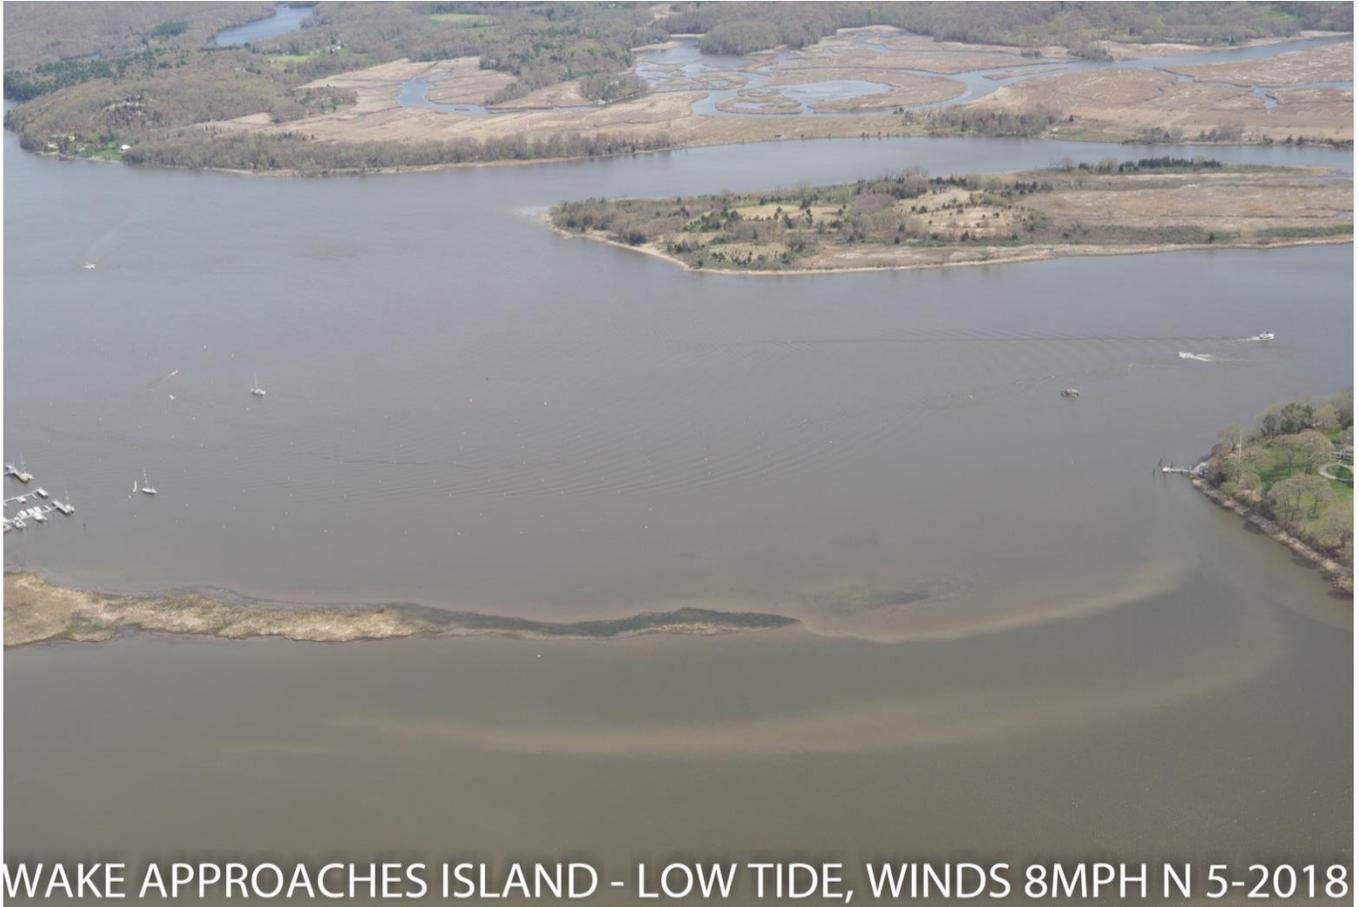
Figure 7. Boat and wind generated wakes

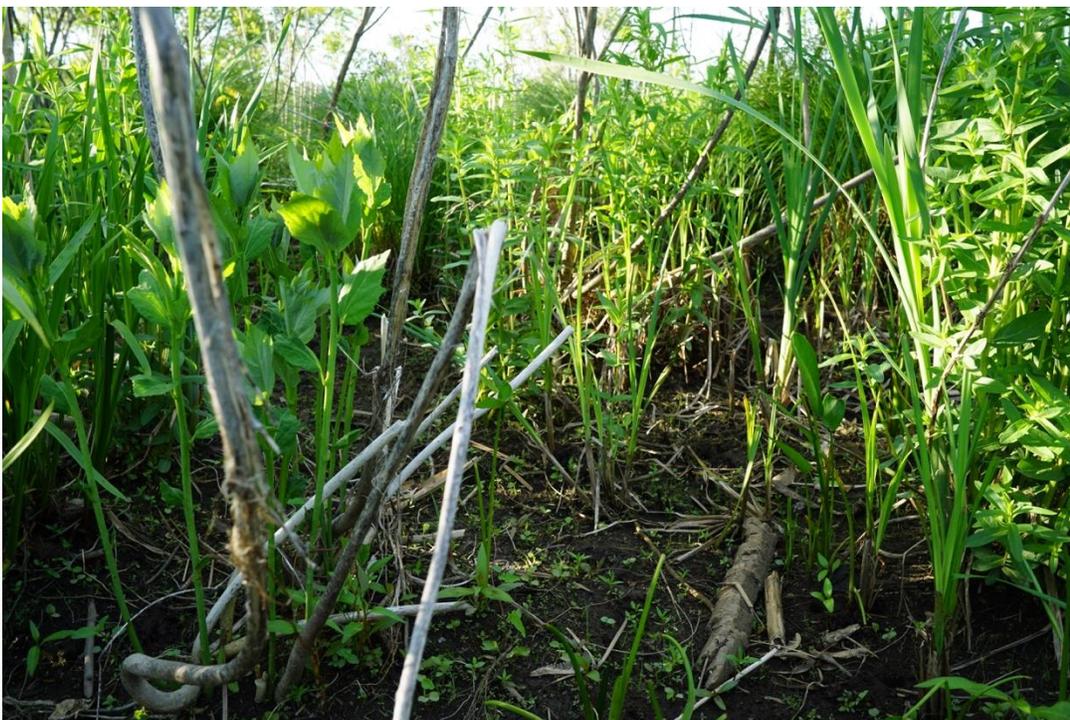
Figure 8: Typical soils on Thatchbed Island

One of the characteristics of Thatchbed Island, which make predictions of growth areas and viable species difficult, is the surface. Conditions of the soil composition and stability vary to a surprising extent across the island. The soils were rocky or actually had visible exposed areas of rock. In other cases, they were loosely consolidated such that the soils would not even support human weight. Soil bearing capacity two feet apart could change from supporting foot pressure to sinking in a foot or two into the sediments. In other cases, frequently close by, they were firm enough to walk on without significant deformation. Areas of vegetation were variable in these different soil conditions and the variations were visibly unpredictable and sporadic. (Figure 8.)

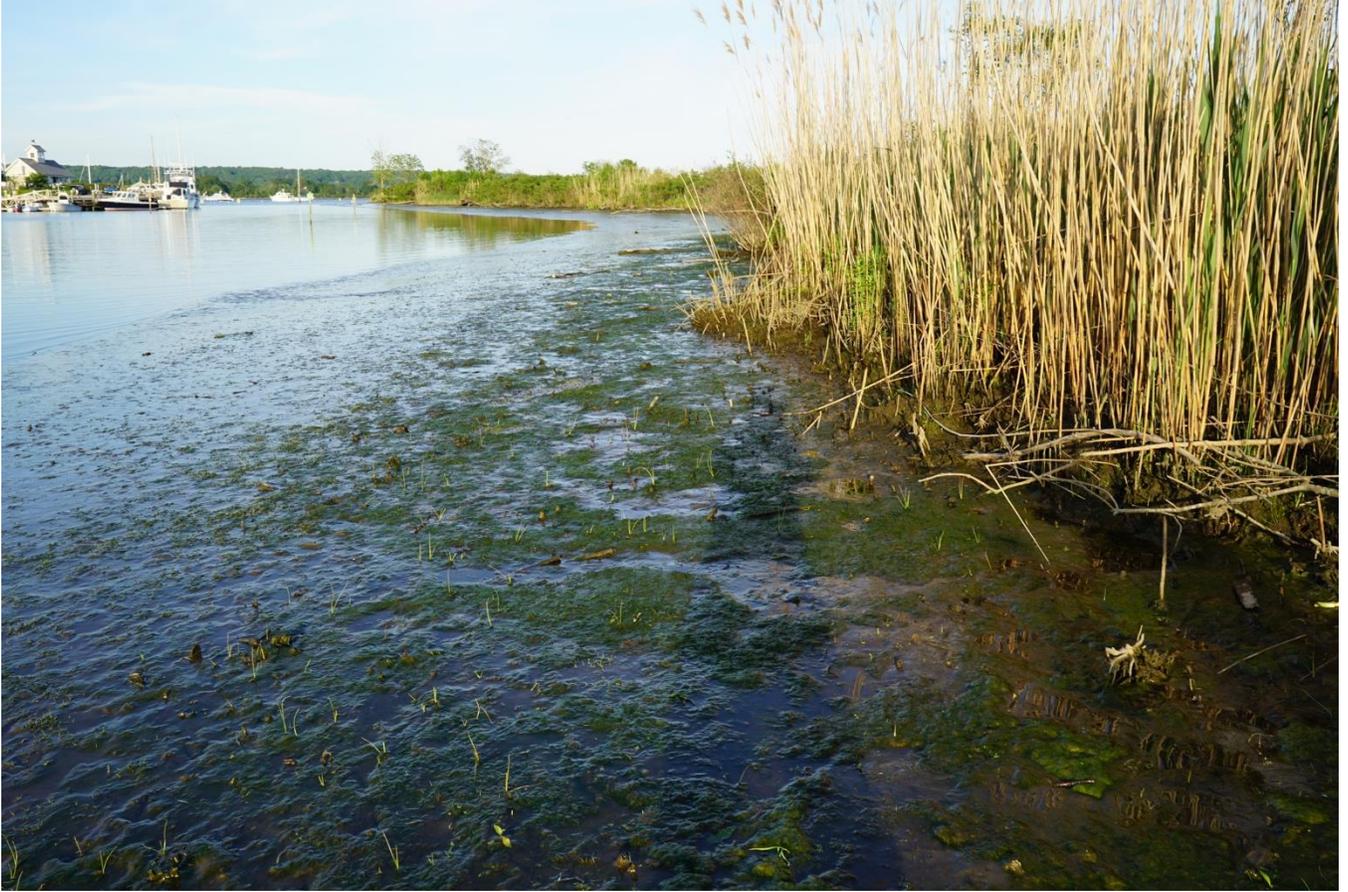
Figure 9. Mud flats on northern shoreline

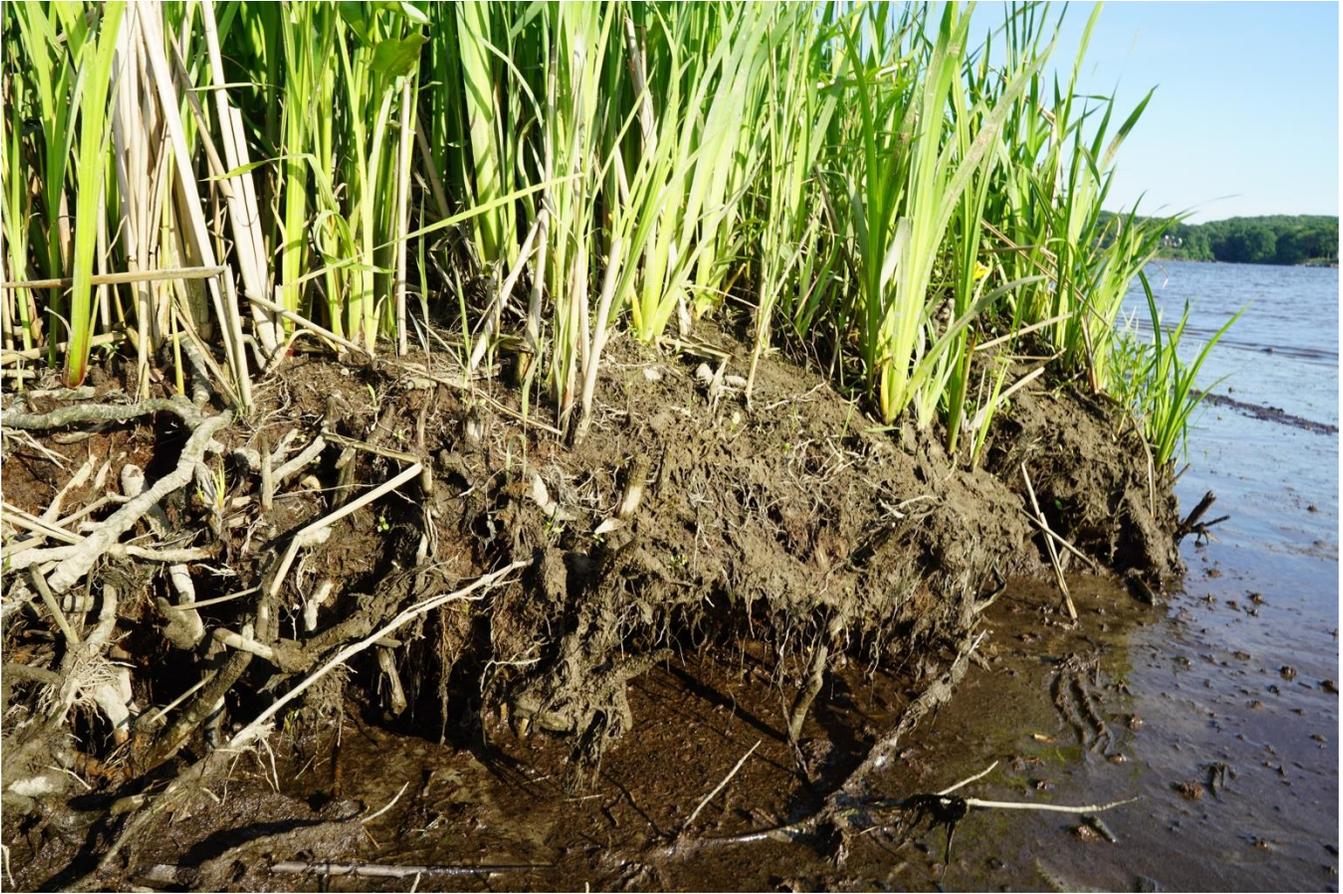
Figure 10. Island bank exposed at low tide

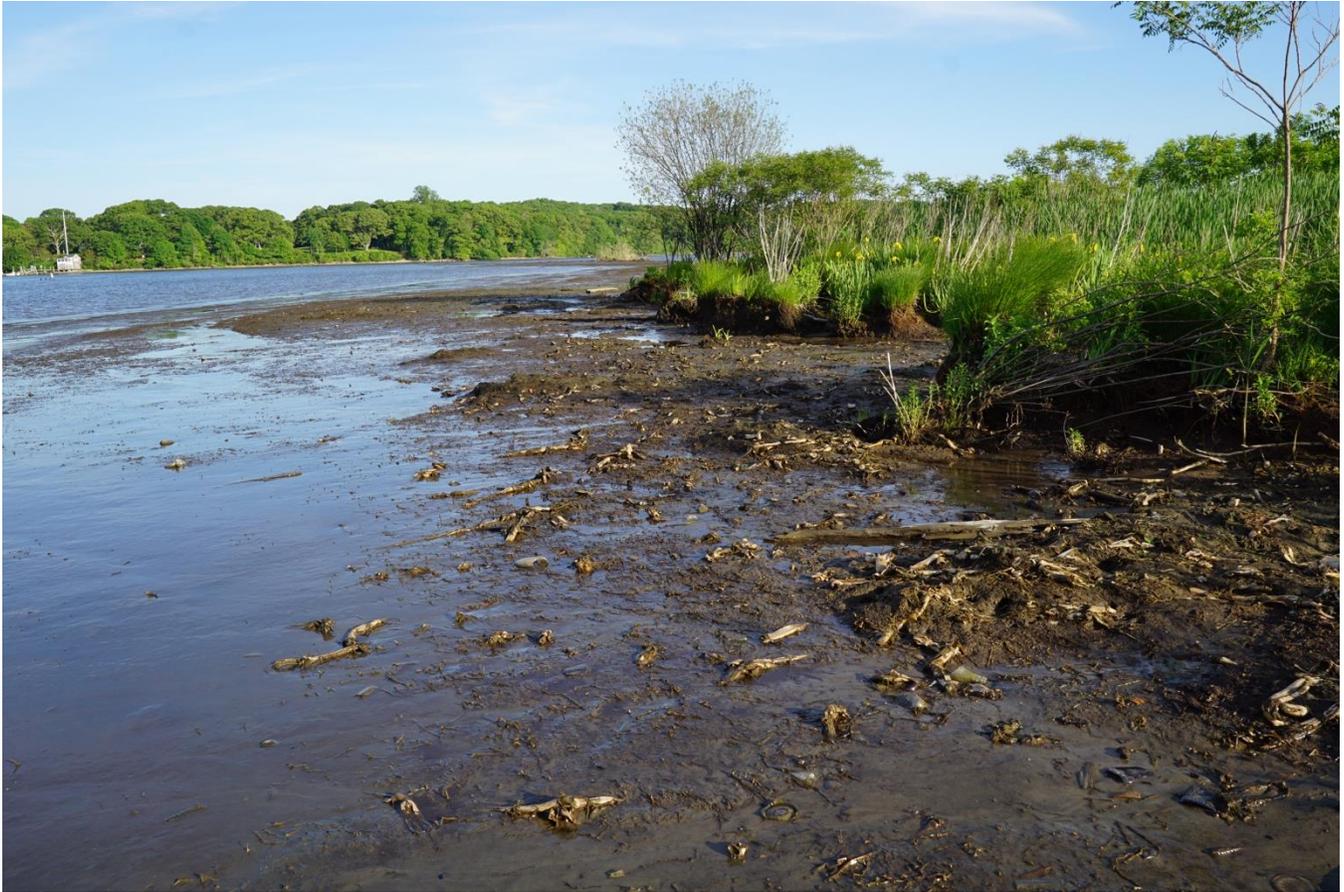
Figure 11. Mud flats exposed at low tide, north-western corner of island

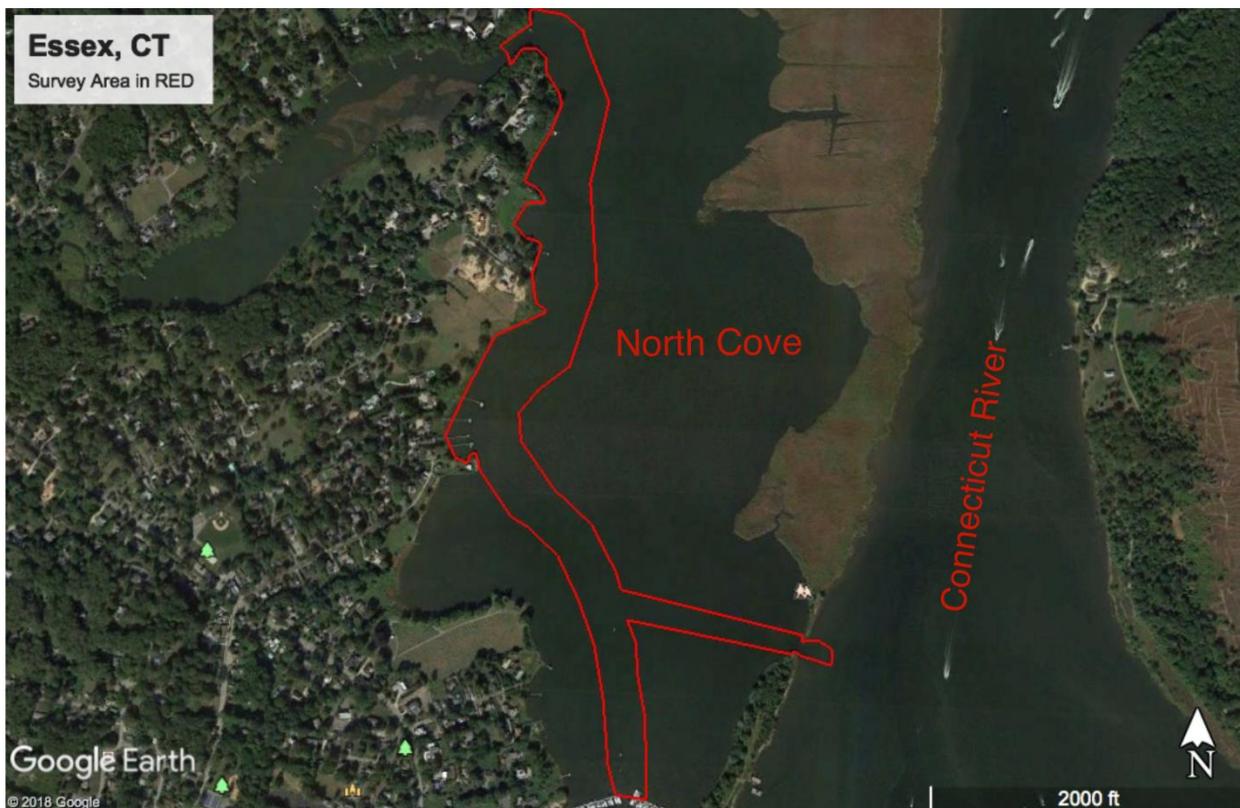
Figure 12: Survey Areas; North Cove, Essex Harbor, Connecticut River, Essex, CT

Site: The survey sites are located in Essex Harbor of the Connecticut River in Essex, Connecticut. The areas of interest are Thatchbed Island and the area along its eastern shore, Middle and South Coves and their entrance channels, and North Cove and its navigation channel (Figure 12. and Figure 13.)

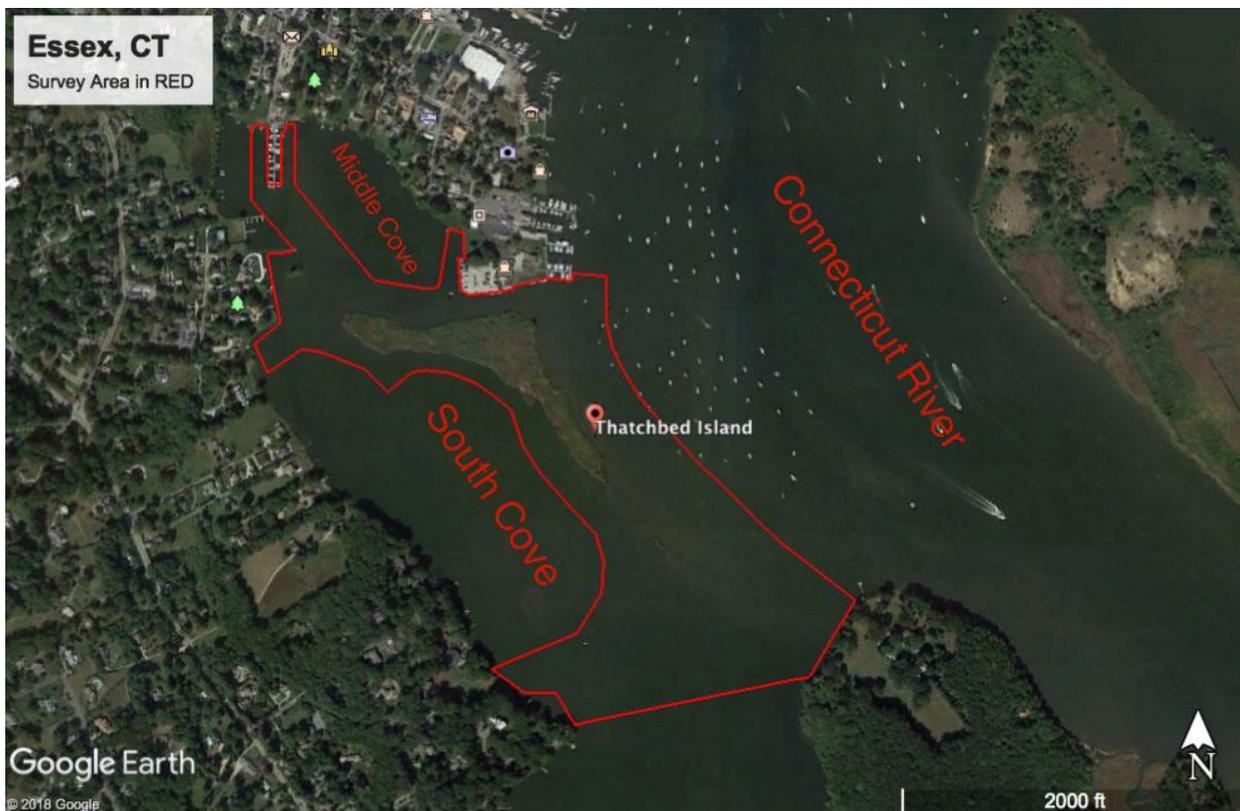
Figure 13: Survey Areas; Thatchbed Island and Middle & South Coves, Essex Harbor, Connecticut River, Essex, CT

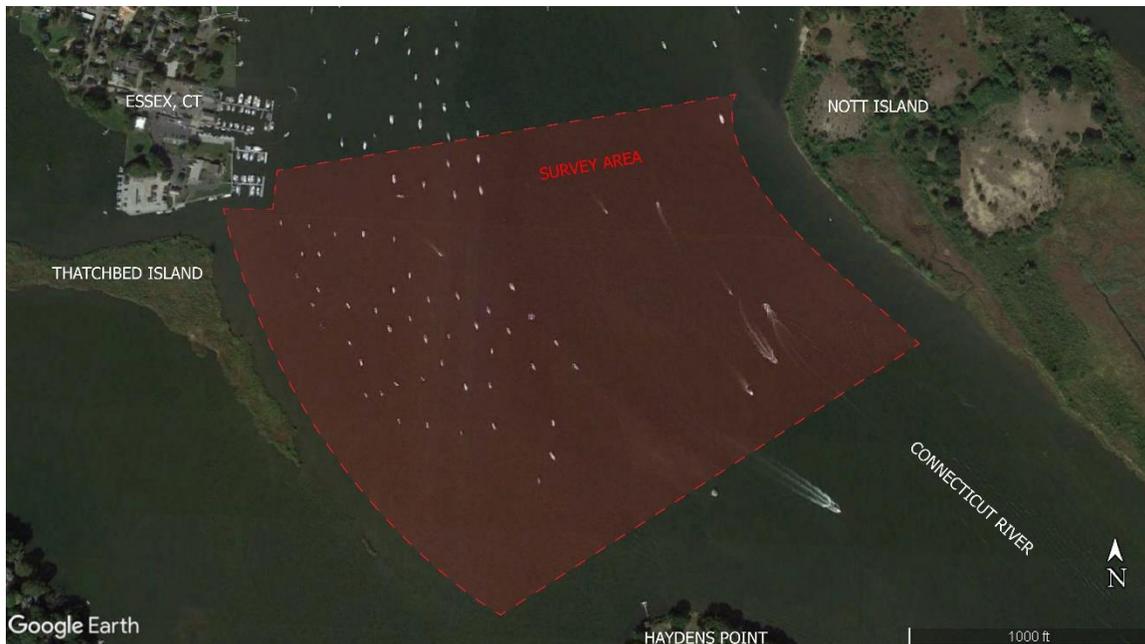
Figure 20: Survey Area; Connecticut River, Essex, CT

On July 11, 2018, measurements of tidal currents were collected in the Connecticut River east of Thatchbed Island in Essex Harbor, Essex Connecticut (Figure 20). Hydro Data Inc. performed this survey to assist efforts in analyzing currents in the vicinity of Thatchbed Island, which is located on the western side of the river and separates South Cove from the main channel of the Connecticut River.

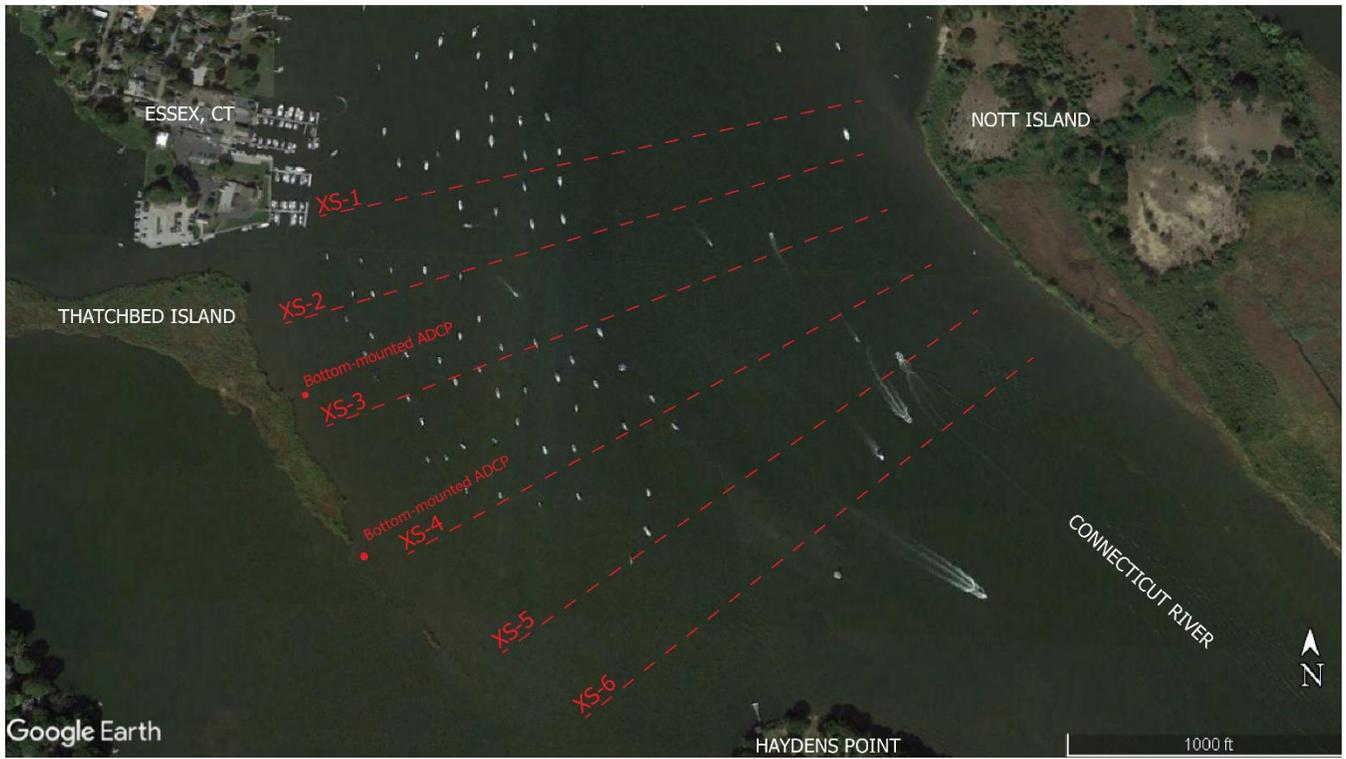
Figure 21: Survey Transects

Current measurements were collected by the ADCP as the vessel navigated repeatedly along a series of six (6) pre-defined transect lines running from east to west across the river and two to three transect running south to north in the survey area (Figure 21.). The line-cycles were repeated five times throughout the survey day. The first cycle was begun at 0730 hours (Eastern Daylight Time, EDT) and the final cycle was completed at 1410 hours (EDT). Two data sets were collected during flood tide, the second of which was collected during maximum flood current. Three data sets were collected during the outgoing (ebb) tide. The first was shortly after high tide when the currents were slack, with the following two data sets collected during ebb tide (Figure 22.)

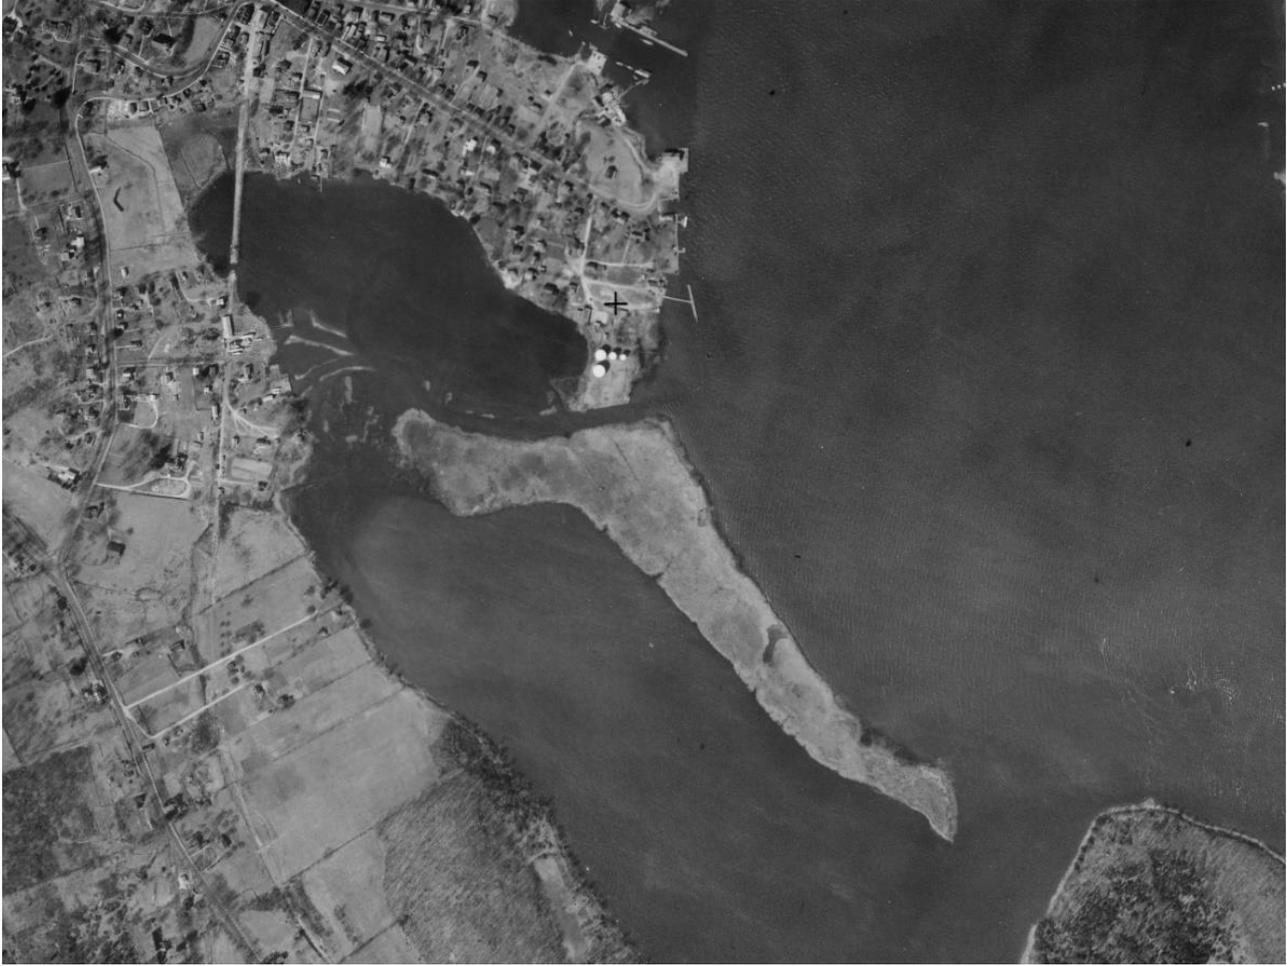
Figure 36. Aerial Photograph, 1934. Note side casting of dredge spoils adjacent to navigation channel in middle cove.

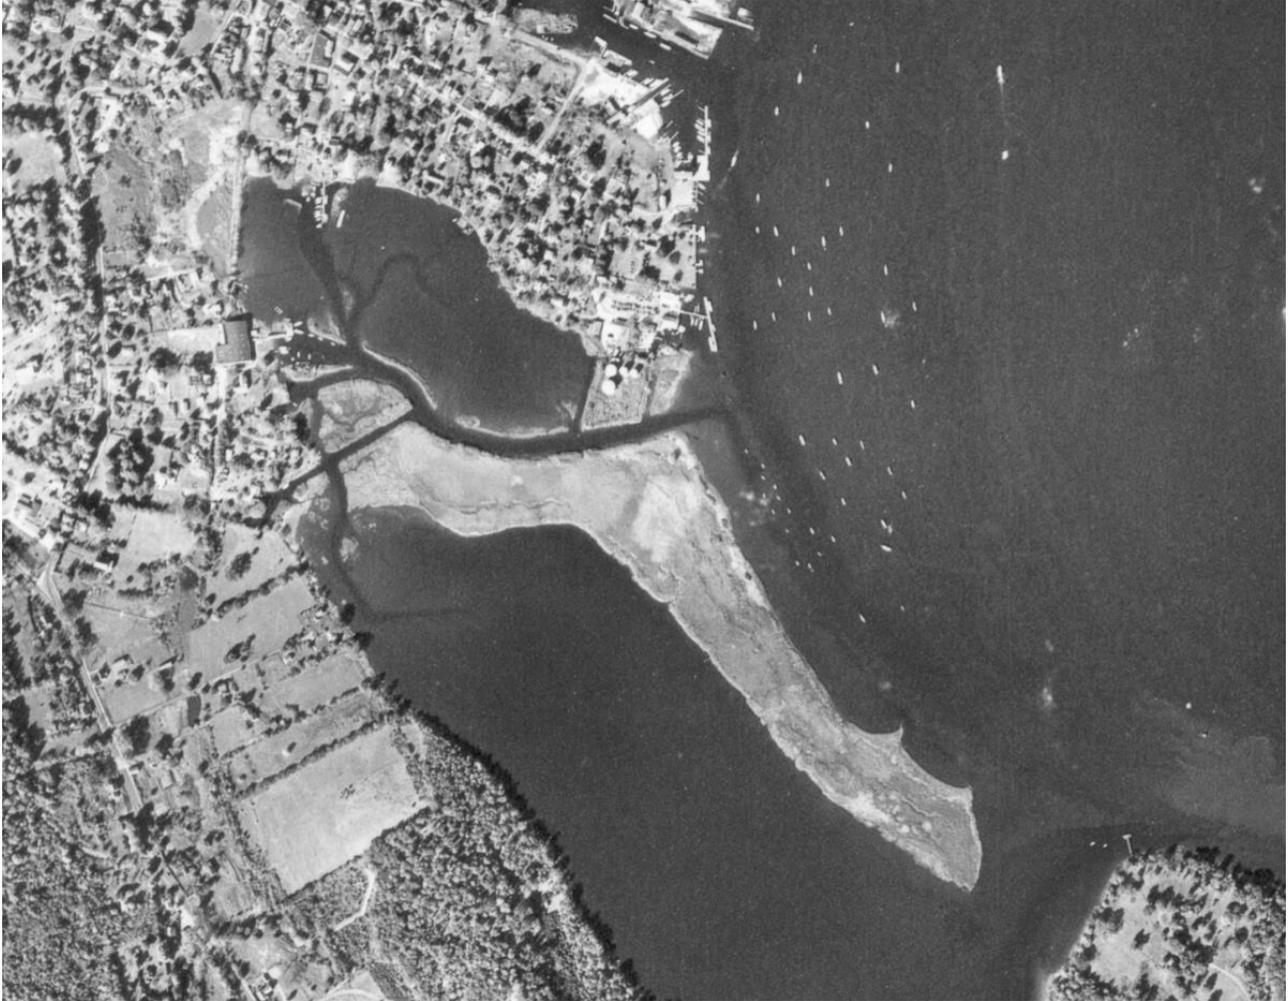
Figure 37. Aerial Photograph, 1951. Photo taken during low tide. Land extends out to two rock piles located at southeast side of Island. Today these rock piles are far from the Thatchbed Island shoreline.

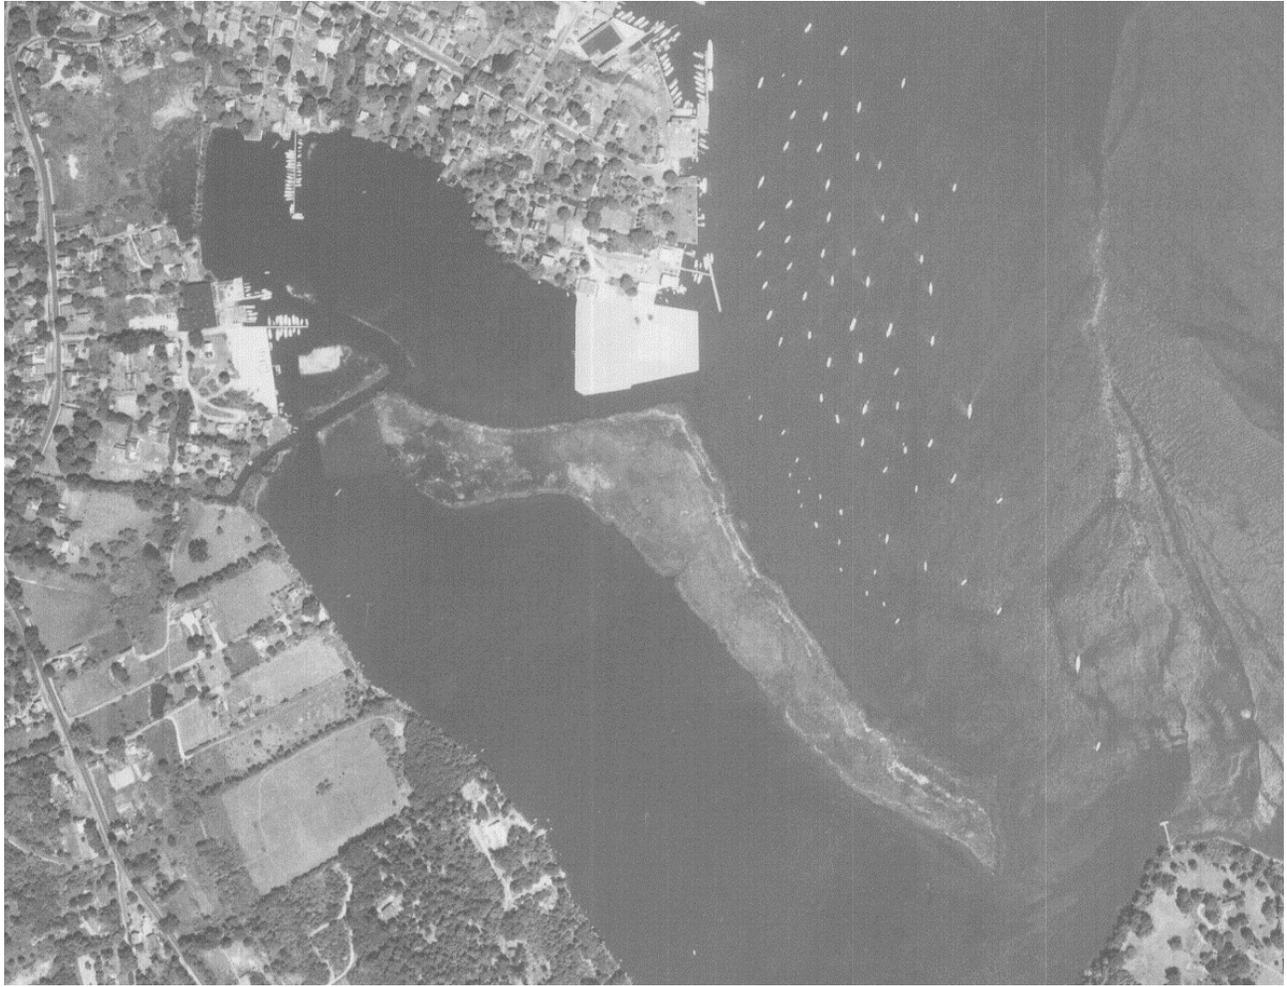
Figure 38. Aerial Photograph, 1957. Note development of Essex Yacht Club area and marina located at west end of middle cove. Dredging activity around the western end of Thatchbed Island

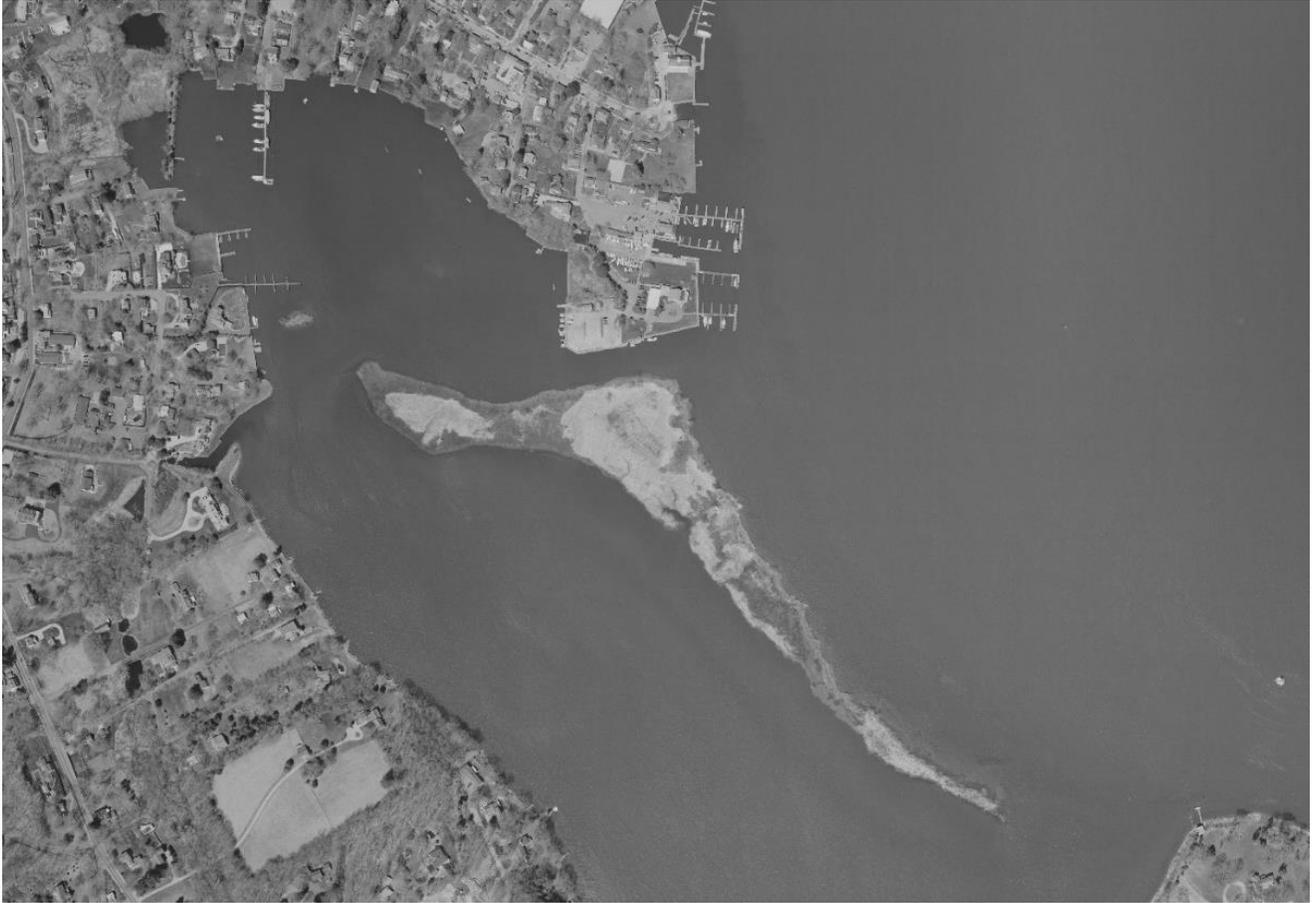
Figure 41. Aerial Photograph, 2004. Note: Image shows Island vegetation recently mowed. The southern end of the Island is narrower than seen in 1990 photograph. Erosion rate increases (see graph below).

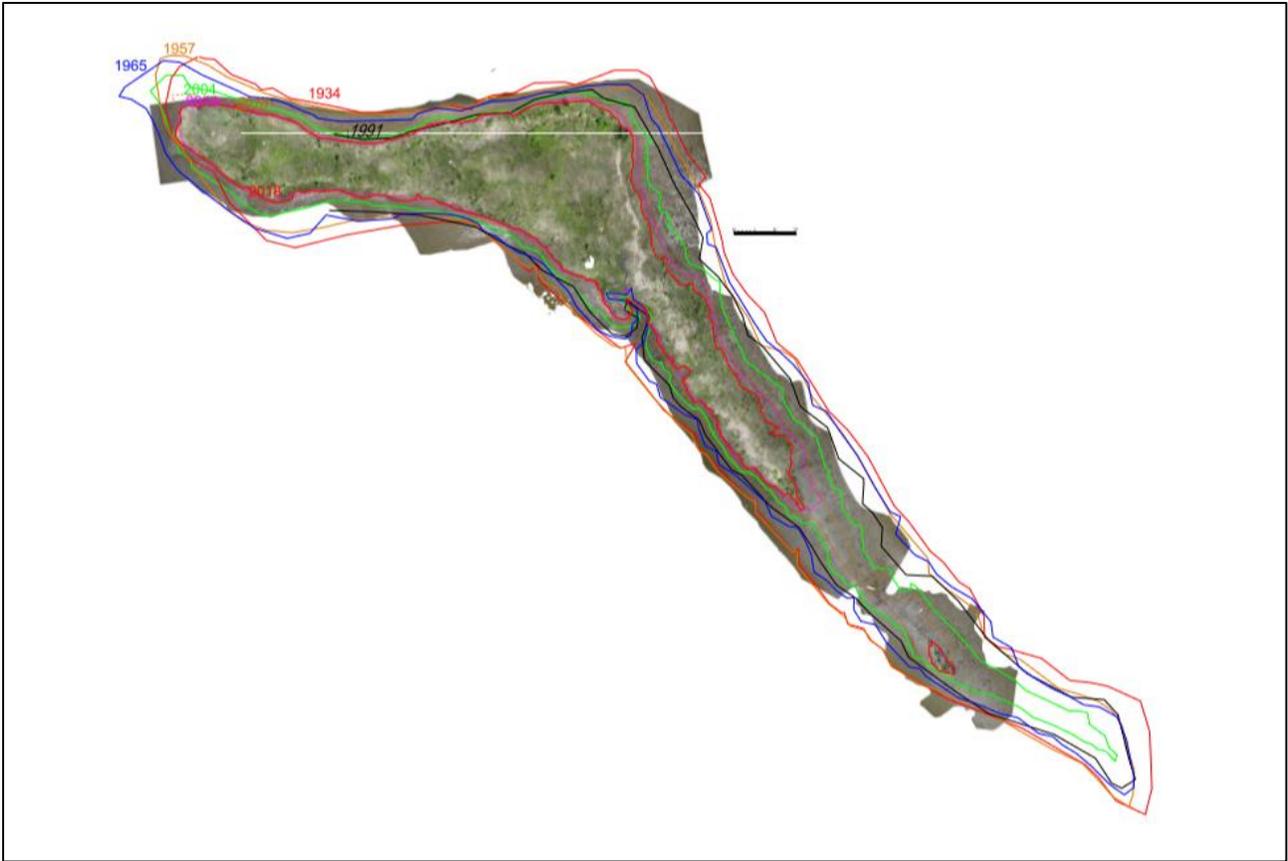
Figure 42. 2018 aerial image with shoreline traced.
