#### CEASE AND CORRECT ORDER

#### Re: Cease and Correct

At 46 Main Street and 1 Johnny Cake Lane Ivoryton, CT 06442 Assessor Map 56, Lot 11 and Map 56 Lot 38-01, respectively

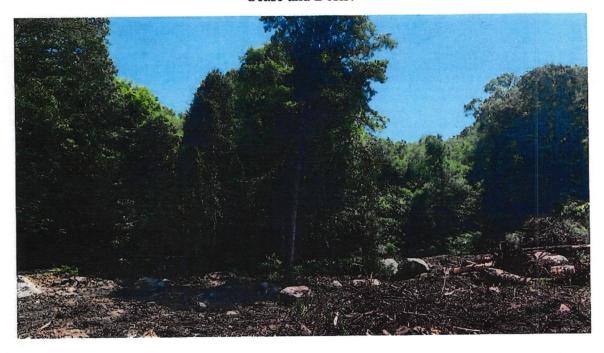
Photo 1 facing southeast, Johnny Cake Lane is to the left of the photo. The stream is to the lower left in the photo and continues to the middle of the photo. The area was cleared of all vegetation without a permit. Photo taken June 2, 2023 by Carey Duques

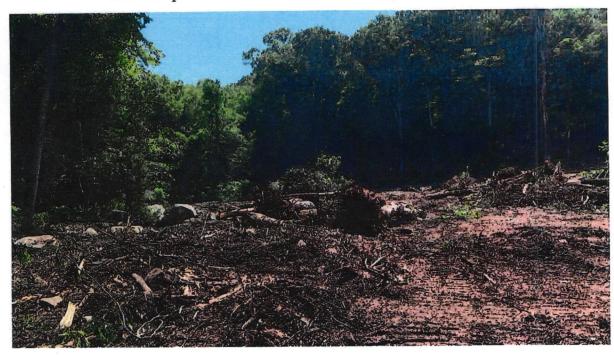
Photo 2 facing south. The area was cleared of all vegetation without a permit. Photo taken June 2, 2023 by Carey Duques

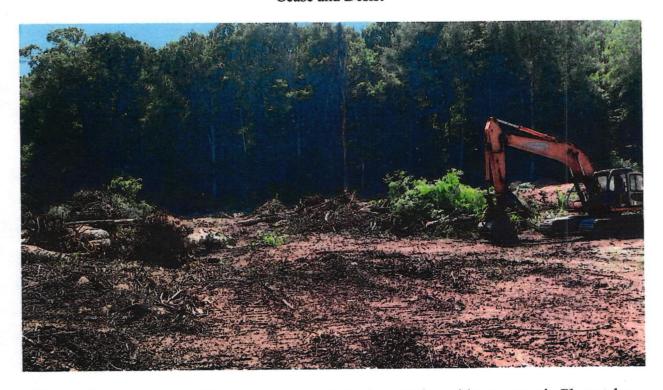
Photo 3 facing southwest. The area was cleared of all vegetation without a permit. Photo taken June 2, 2023 by Carey Duques

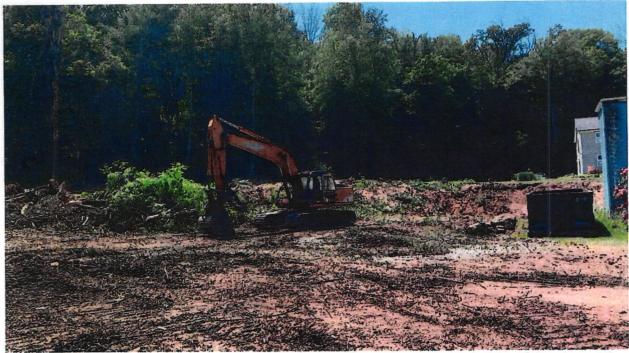
Photo 4 facing west. The guest houses of the Copper Beech Inn are to the right of the photo. The area was cleared of all vegetation without a permit. Photo taken June 2, 2023 by Carey Duques

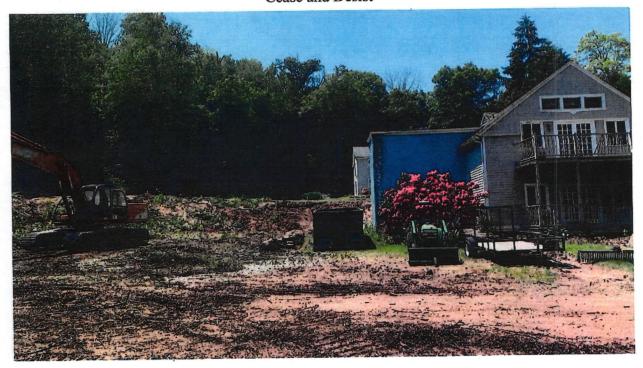
Photo 5 facing west. The guesthouses of the Copper Beech Inn are on the right side of the photo. The area was cleared of all vegetation without a permit. Photo taken June 2, 2023 by Carey Duques

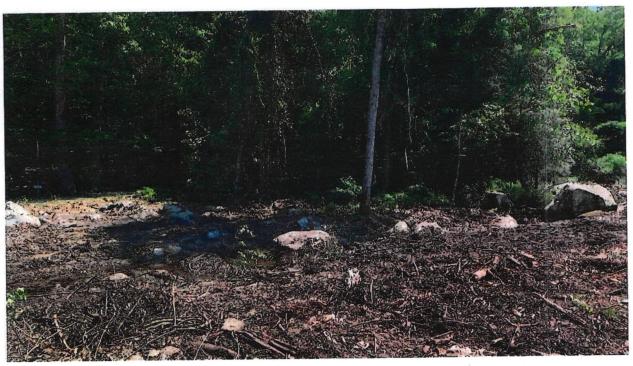
Photo 6 facing southeast, Johnny Cake Lane is to the left of the photo. The stream is to the lower left in the photo and continues to the middle of the photo. Standing water is visible in the photo. Photo taken June 2, 2023 by Carey Duques

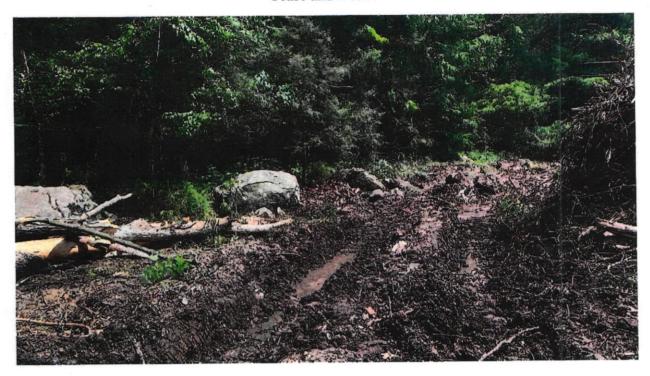
Photo 7 facing southeast. Standing water visible in the foreground of the photo where the excavator sank into the soil. Photo taken June 2, 2023 by Carey Duques

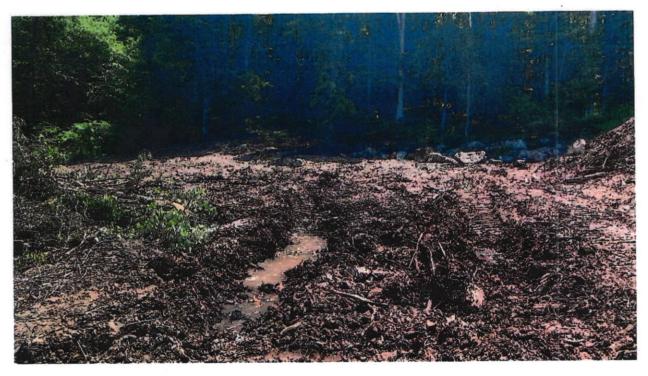
Photo 8 facing south, after walking further into the property away from the guest houses of the Copper Beech Inn. Standing water visible where tracks from the machinery exist. Photo taken June 2, 2023 by Carey Duques

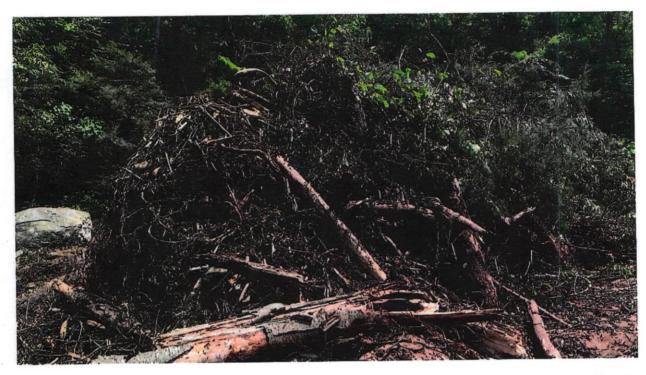
Photo 9 facing southeast, approximately midway into the rear of the property is a brush pile of vegetation that was cleared without a permit. Photo taken June 2, 2023 by Carey Duques

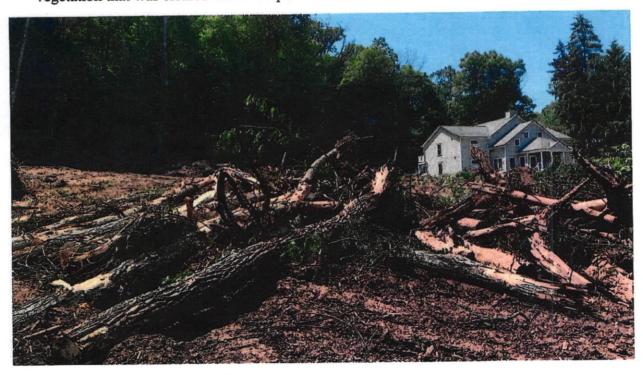
Photo 10 facing northwest, the guest house on the western side of the property is in the background. Piles of trees and brush removed without a permit in the foreground. Photo taken June 2, 2023 by Carey Duques

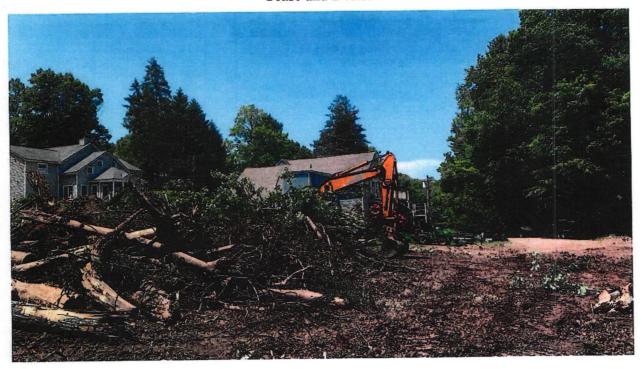
Photo 11 facing north, pile of brush in the foreground and guest houses of Copper Beech Inn in the background. Photo taken June 2, 2023 by Carey Duques

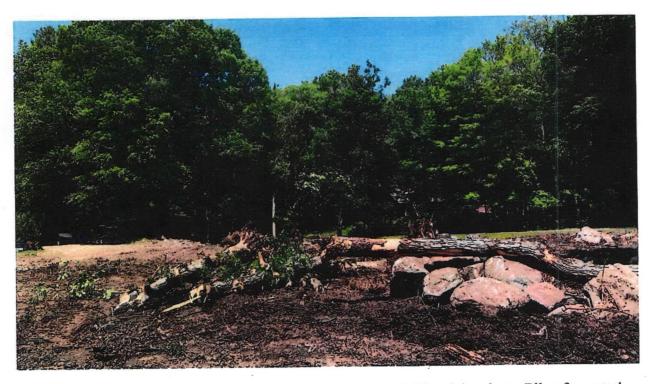
Photo 12 facing northeast, Johnny Cake Lane is along the middle of the photo. Pile of vegetation and stones removed without permits. Photo taken June 2, 2023 by Carey Duques

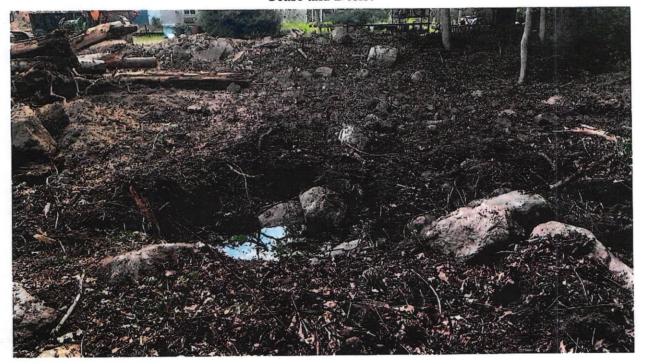
Photo 13 facing northwest taken from the side of the stream closest to Johnny Cake Lane. The stream is in the foreground of the photo and runs from left to right. Photo taken June 2, 2023 by Carey Duques

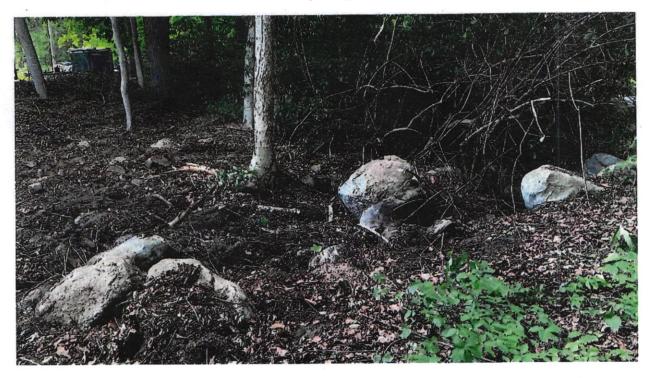
Photo 14 facing north taken from the side of the stream closest to Johnny Cake Lane. The stream is in the foreground of the photo between the boulders and runs from left to right. Photo taken June 2, 2023 by Carey Duques

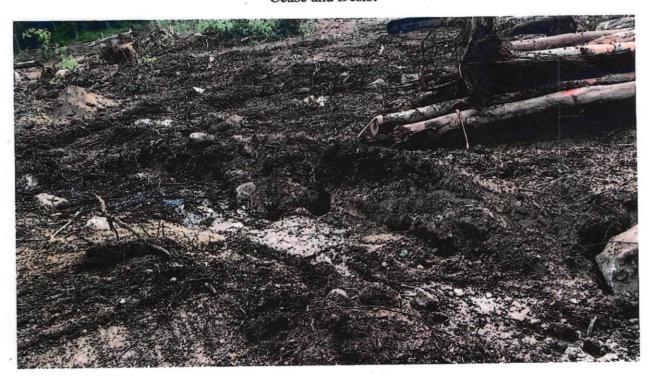
Photo 15 facing south looking at the stream from the side closer to Johnny Cake Lane. Dirt and debris has been placed in the stream. Photo taken June 2, 2023 by Carey Duques

- (5) Monitor the site to ensure that the E&S remains stabilized; and
- (6) Remove the sediment and debris from the stream and hire a Soil Scientist and to develop a full remediation plan for the stream; and

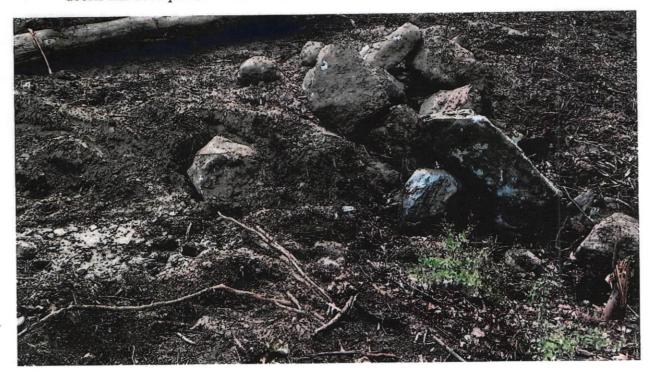
Photo 16 facing west looking at the stream from the side of the stream closest to Johnny Cake Lane. The stream runs under the dirt and debris and emerges by the boulders. Photo taken June 2, 2023 by Carey Duques
