### CEASE AND CORRECT ORDER

**Re: Cease and Correct**

At 55 Pond Meadow Road  
Ivoryton, CT 06442  
Assessor Map 83, Lot 4

Appendix A  
Photos 55 Pond Meadow Road Ivoryton, CT  
Cease and Correct

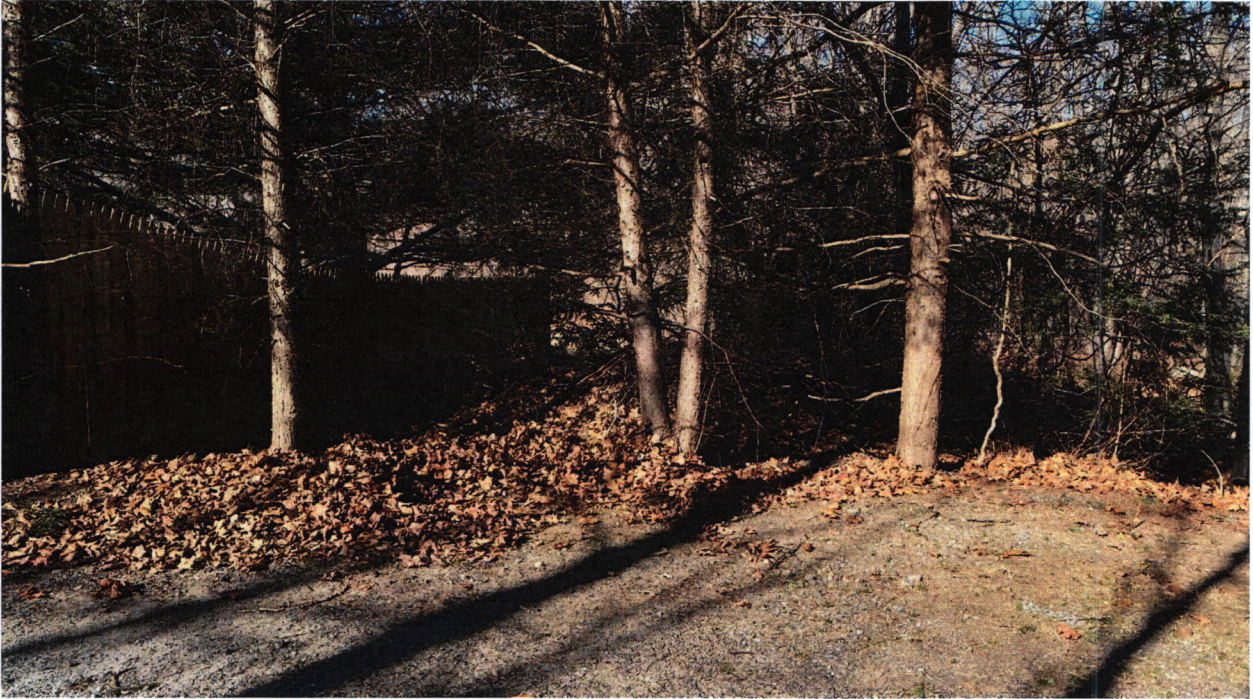
Photo 1a of the rear yard of 55 Pond Meadow Road before work was completed. Area is located within 100 feet of a wetlands. Photo taken February 14, 2023 by Carey Duques

- (1) cease each of the activities enumerated and described above or other activities within the wetlands or watercourses of the Town of Essex without a permit; and
- (2) provide the Essex IWWC with a plan and/or written description showing the types and numbers of plantings that will replace the trees and vegetation located within the 100-foot upland review area of a wetlands that were removed without a permit. A timeline explaining when the work will be completed is also required; and
- (3) pay the appropriate enforcement fee as determined by the Essex IWWC.

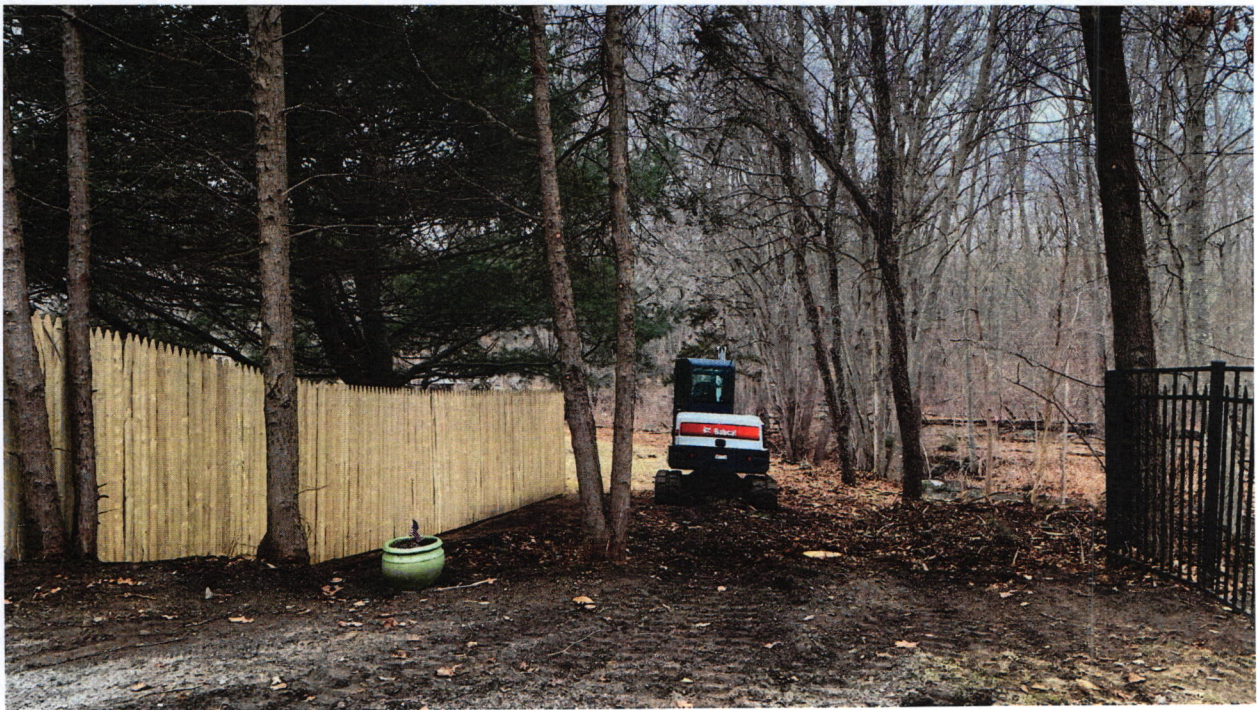
1. Cutting of brush and vegetation within the 100-foot upland review area of a wetlands without a permit (see attached photos).

Photo 1b of the rear yard of 55 Pond Meadow Rd after the leaf pile was removed and brush and 1 pine tree was cut. Photo taken February 21, 2023 by Carey Duques.

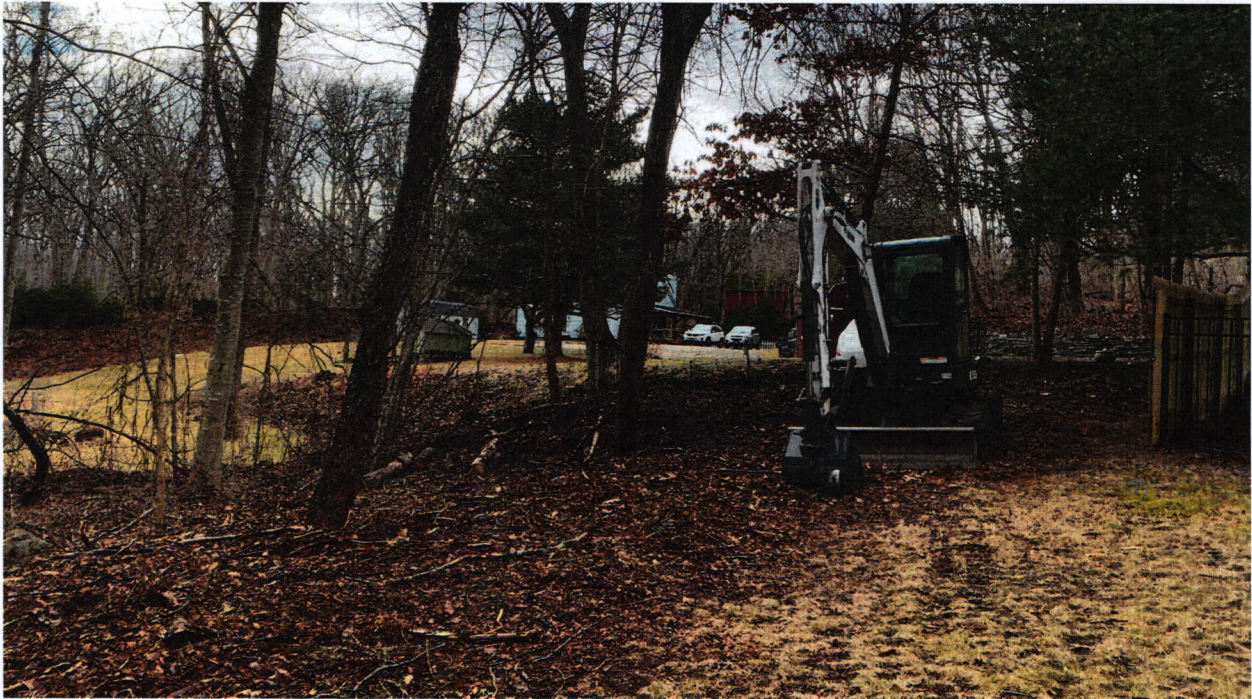
Photo 2 of the rear yard of 55 Pond Meadow Rd facing southeast after the work was done. Brush appears to have been cut and grubbed. Photo taken February 24, 2023 by Carey Duques.

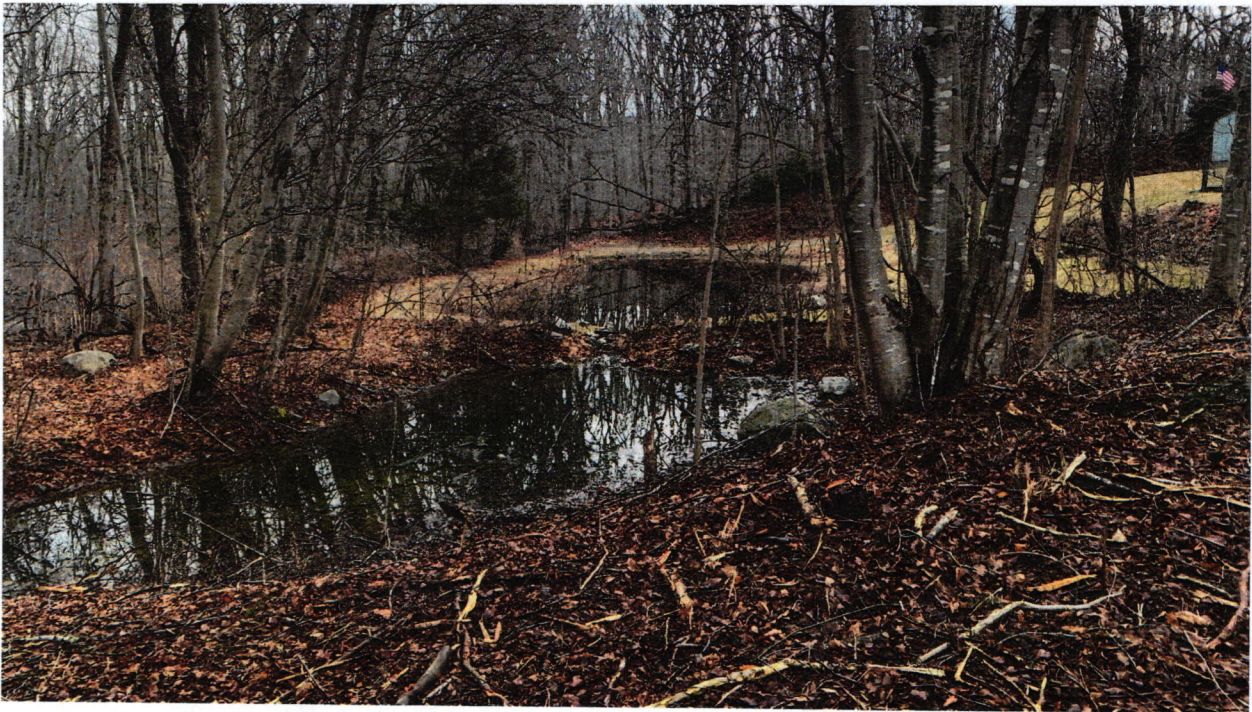
Photo 3 of the rear yard of 55 Pond Meadow Rd facing east after the work was done. Tree stumps were not noticed. Appears that brush and smaller growth was cut. Erosion was not observed on the site. Photo taken February 24, 2023 by Carey Duques.

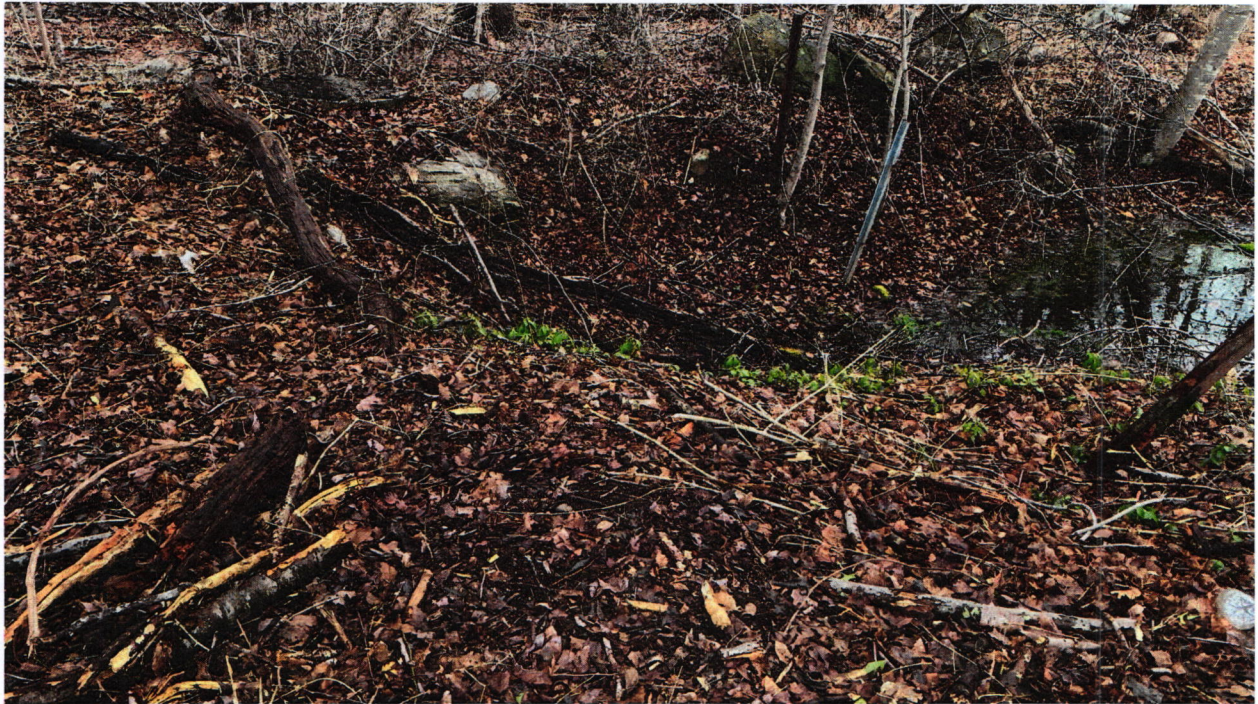
Photo 4 of the rear yard of 55 Pond Meadow Rd facing northeast after the work was done. It's not clear if there is a pipe located in the embankment that is the source of the water that empties into the pond. Photo taken February 24, 2023 by Carey Duques.

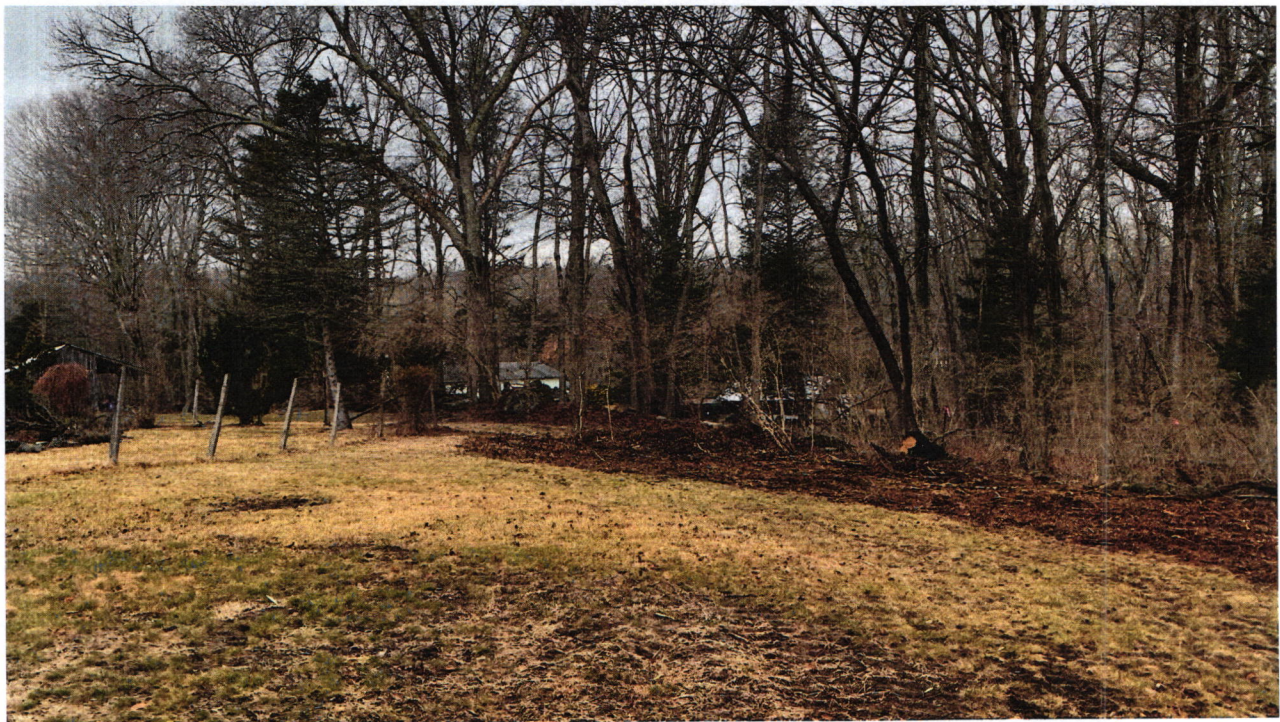
Photo 5 of the rear yard of 55 Pond Meadow Rd facing north after the work was done. Photo taken February 24, 2023 by Carey Duques.

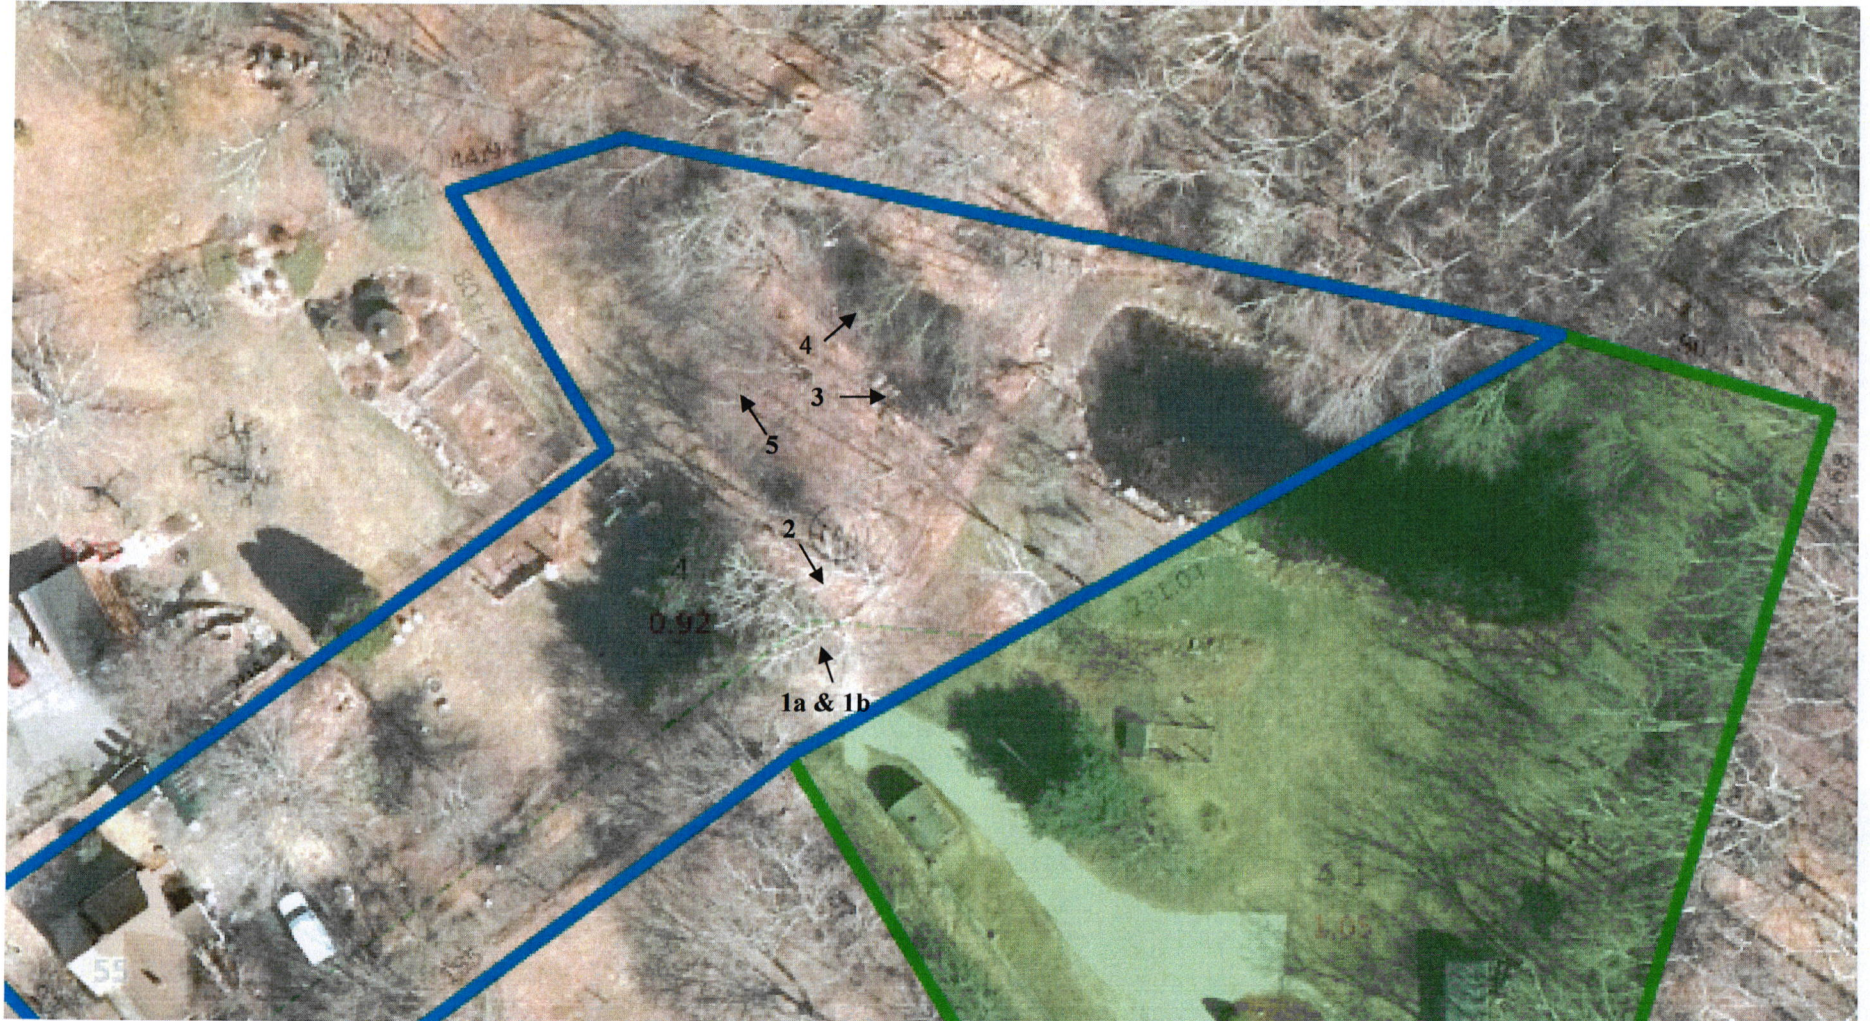
**GIS Image of 55 Pond Meadow Road**  
**Locations where photos were taken are noted below.**

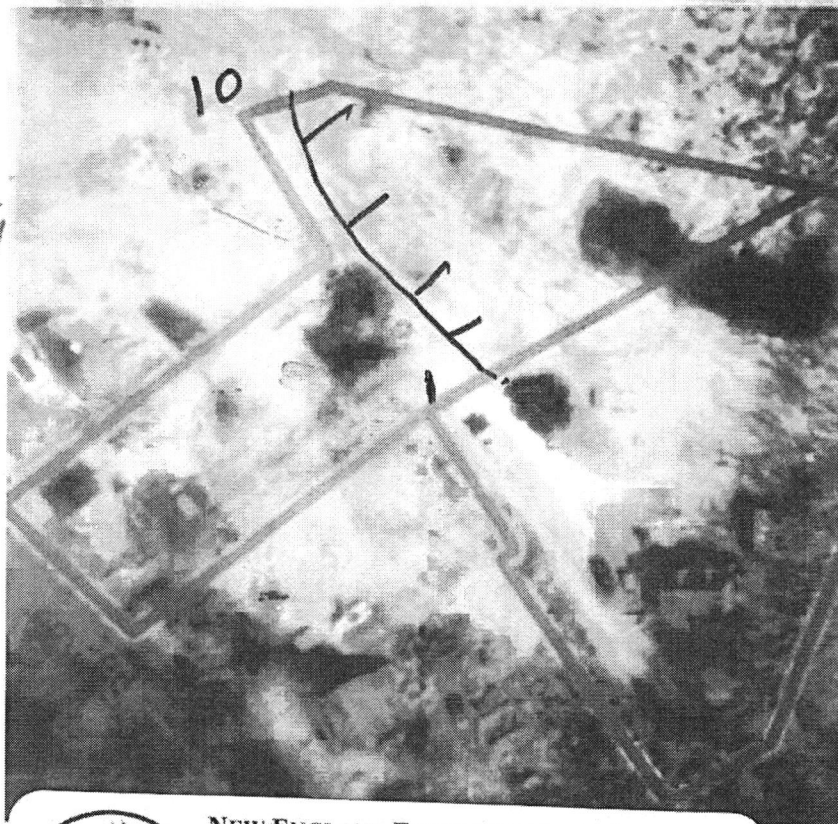
The wetland boundary is  
marked with pink flag  
(+ through 10)
